# 震災豫防調査會報告第一號附圖(甲)

東海道鐵道線路大府大垣間平面圖	六枚 (自其一 至其六)
東海道枝線大府武豐間平面圖	貳枚 (其一)
木曾川橋震害圖	貳枚 (其二)
木曾川橋改造橋脚圖	壹枚
舊木曾川鐵橋橋臺及橋脚圖	壹枚
境川橋震害圖	貳枚 (其三)
境川橋橋臺及橋脚震害明細圖	貳枚 (其二)

# 東海道鐵道線路大府大垣間平面圖

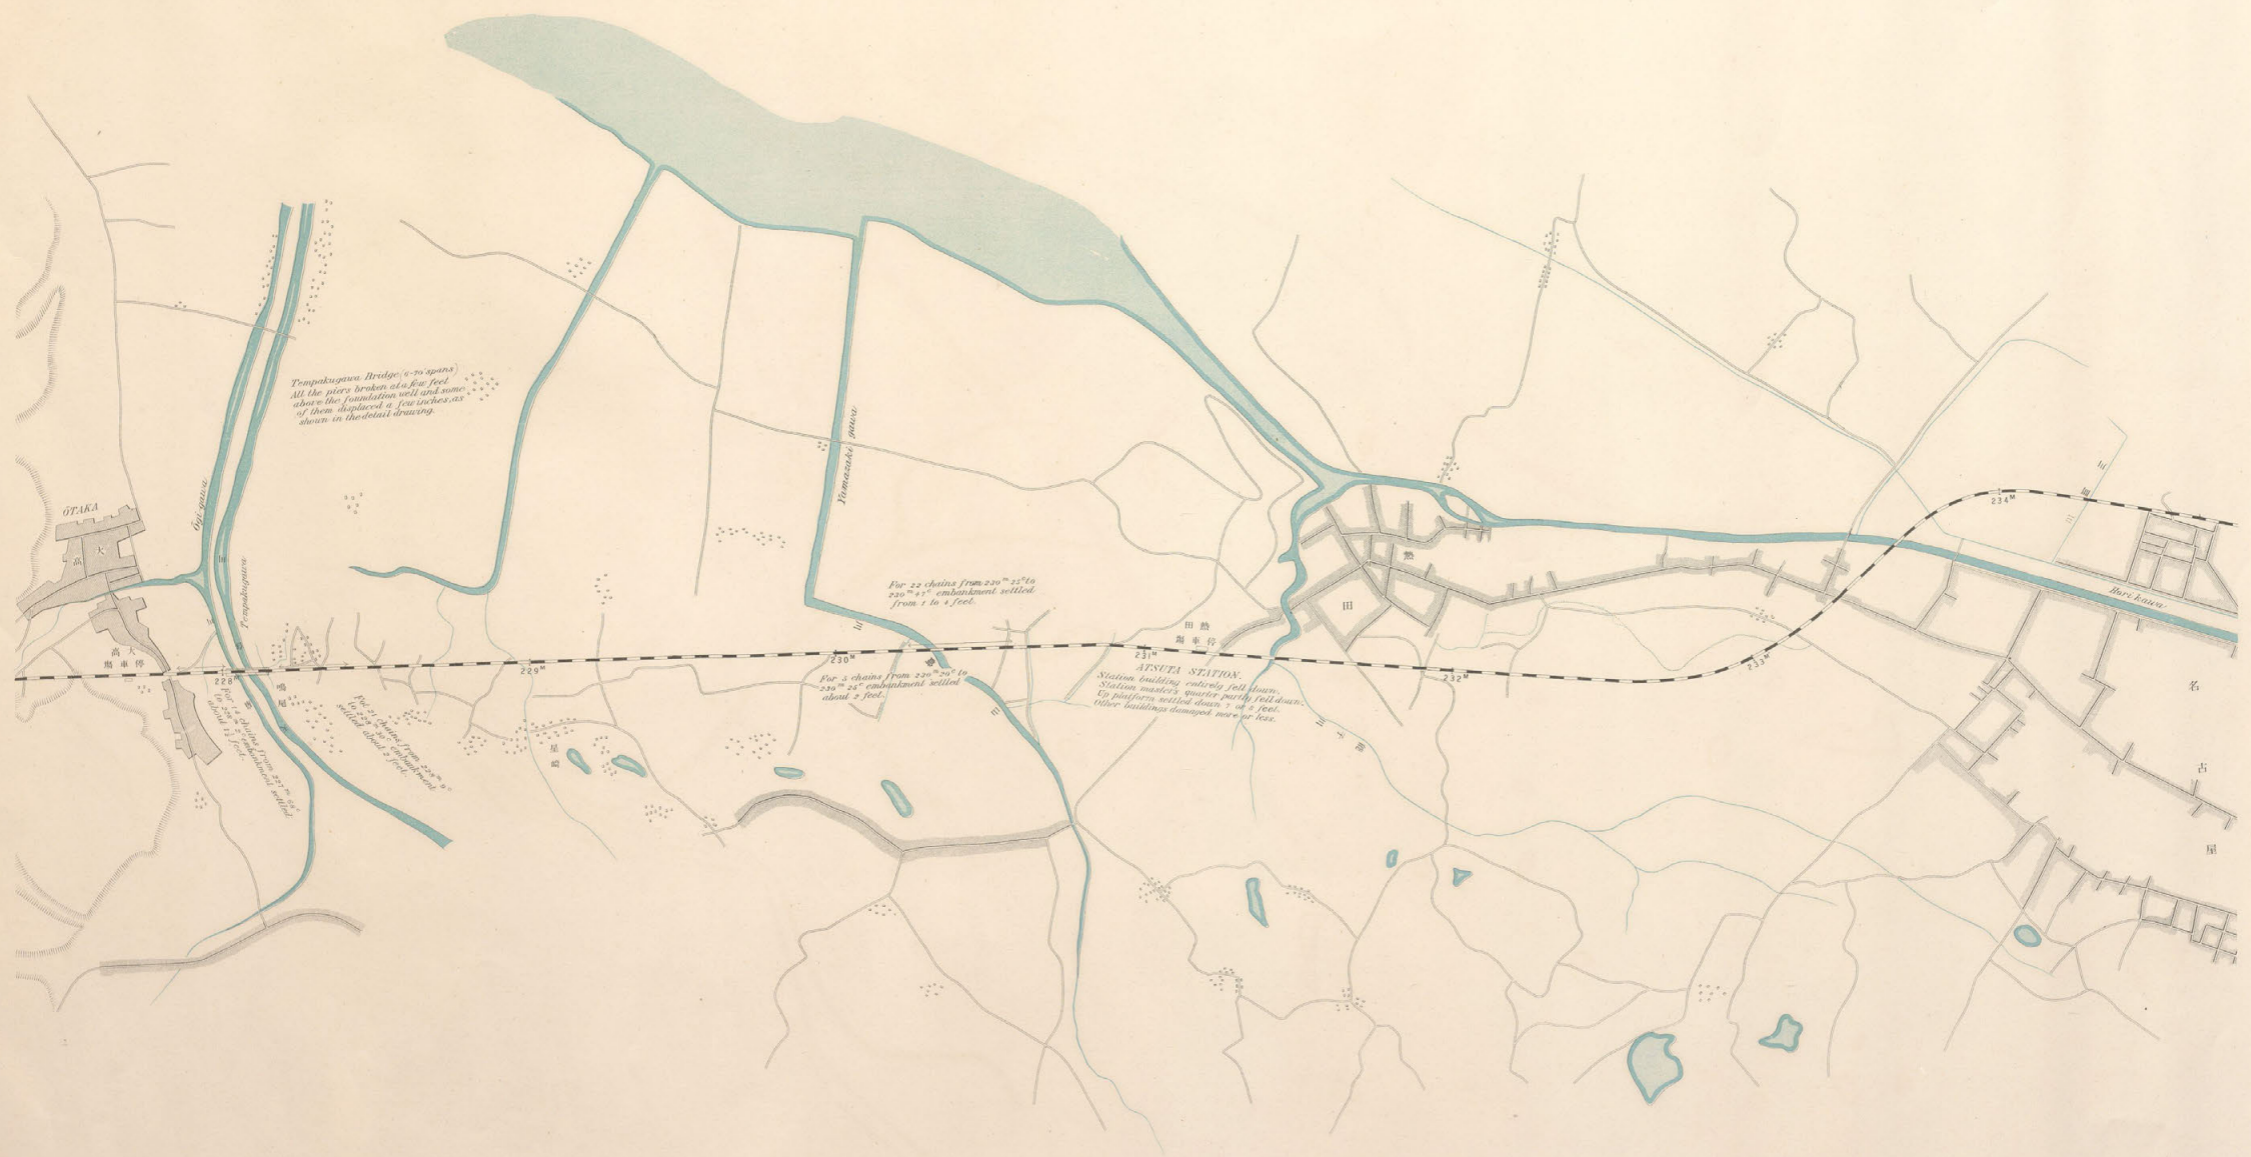
Tombakugawa Bridge (6-75 spans)  
All the piers broken also the feet  
above the foundations well and some  
of them displaced a few inches as  
shown in the detail drawing.

For 23 chains from 220° 25' to  
230° 25' embankment settled  
from 1 to 4 feet.

For 23 chains from 220° 25' to  
230° 25' embankment settled  
about 4 feet.

AIZUTA STATION.  
Station building entirely fell down.  
Station master's quarters partly fell down.  
Up platform settled down 7 or 8 feet.  
Other buildings damaged more or less.

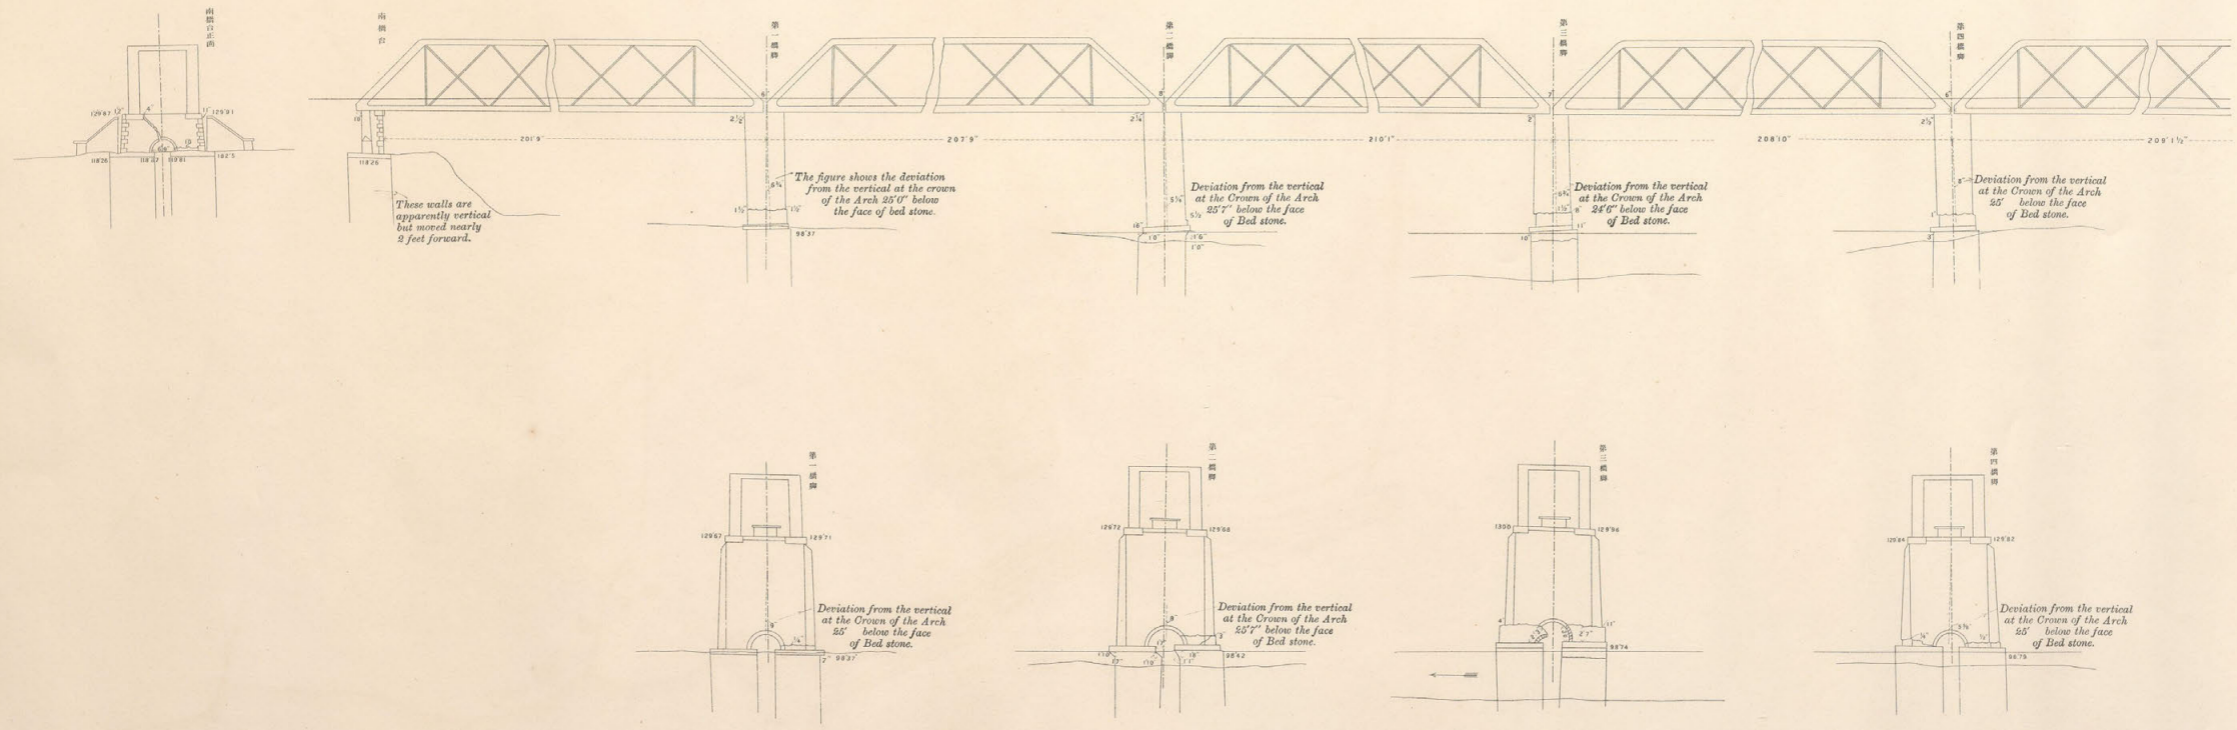
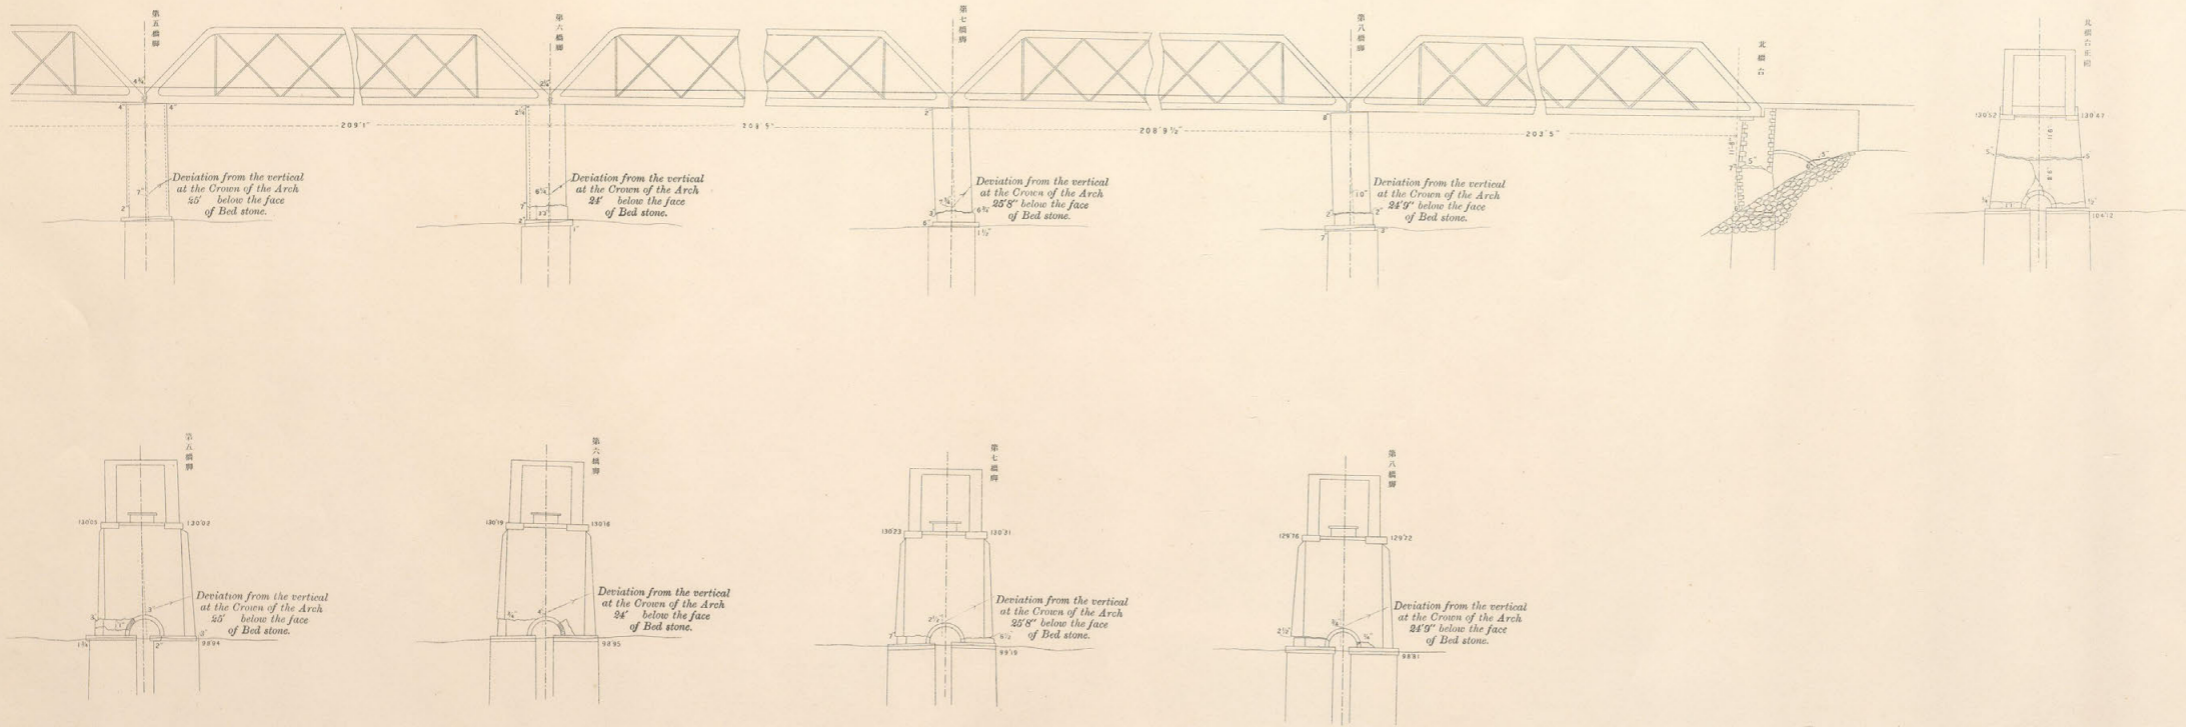
本會川橋震害圖(其一)

Showing the condition after the earth  
All piers and abutments cracked at a few feet ab  
less displaced in var  
Scale: 20 ft. to

quake disaster of Oct. 28th, 1891.

ove the top of foundation wells and more or  
ious directions.

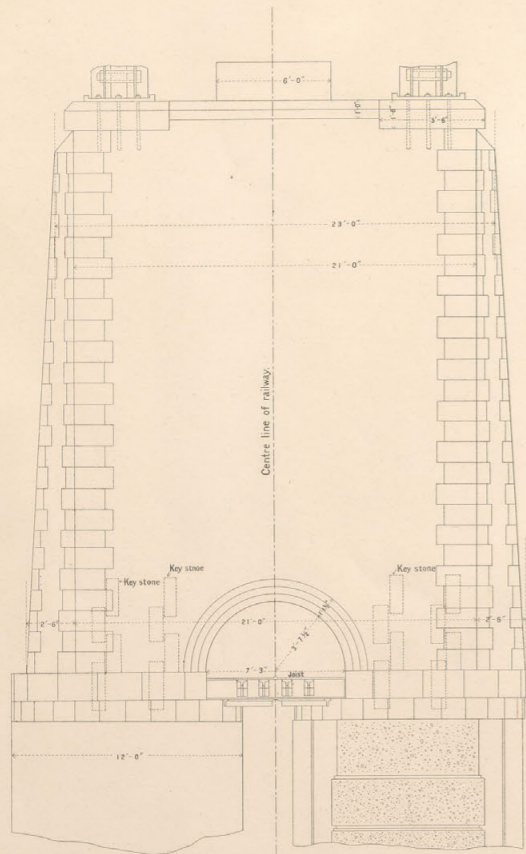
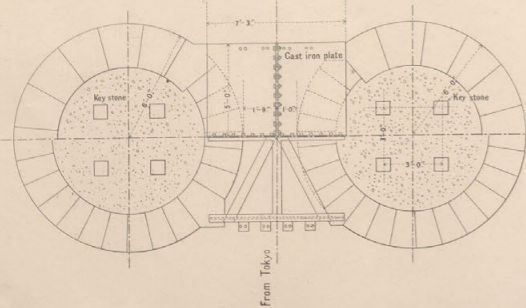
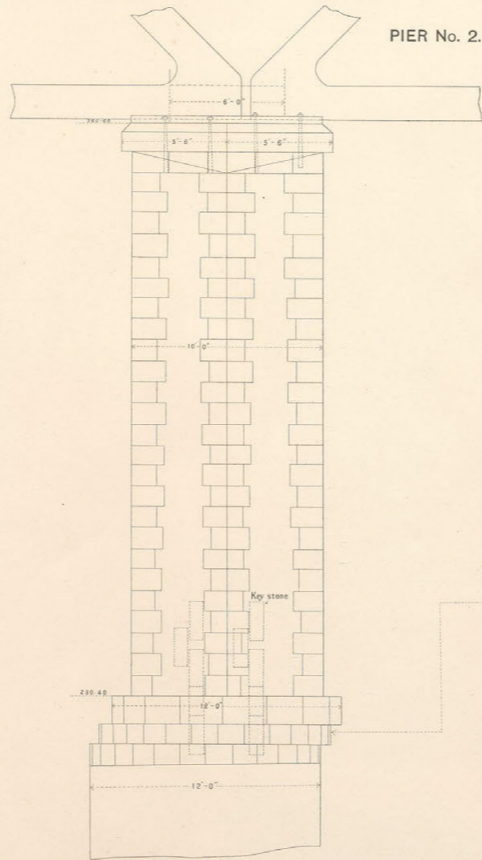
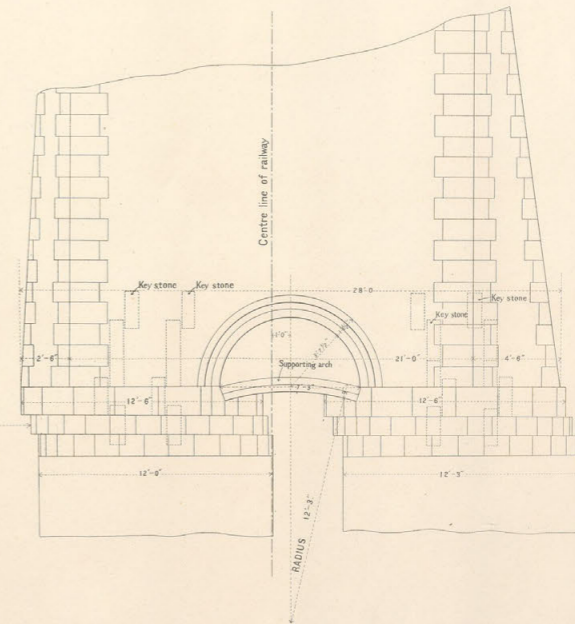
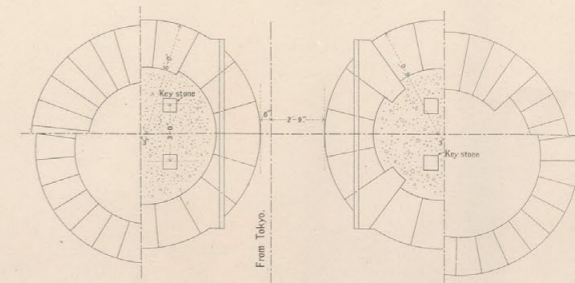
## PIERS OF KISOGAWA BRIDGE.

Foundation north of No. 2 pier has been shown out of their proper position by foot, while in construction work resulted in producing this irregularity, so that displacement is not due to the effect of earthquake.

As reconstructed after the earthquake disaster, by filling up the space under joining arch with brick work, supported by cast iron plate or by light sectional brick arch and using several keystones, built in near the bottom of piers in view to resist horizontal thrust.

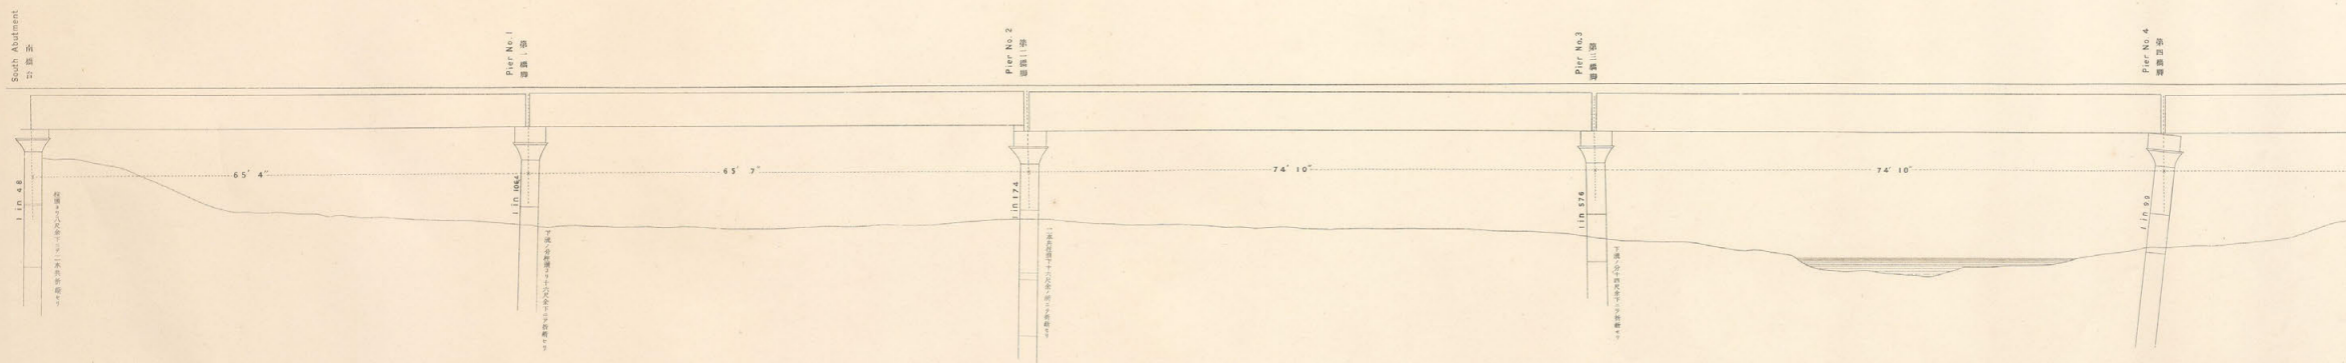
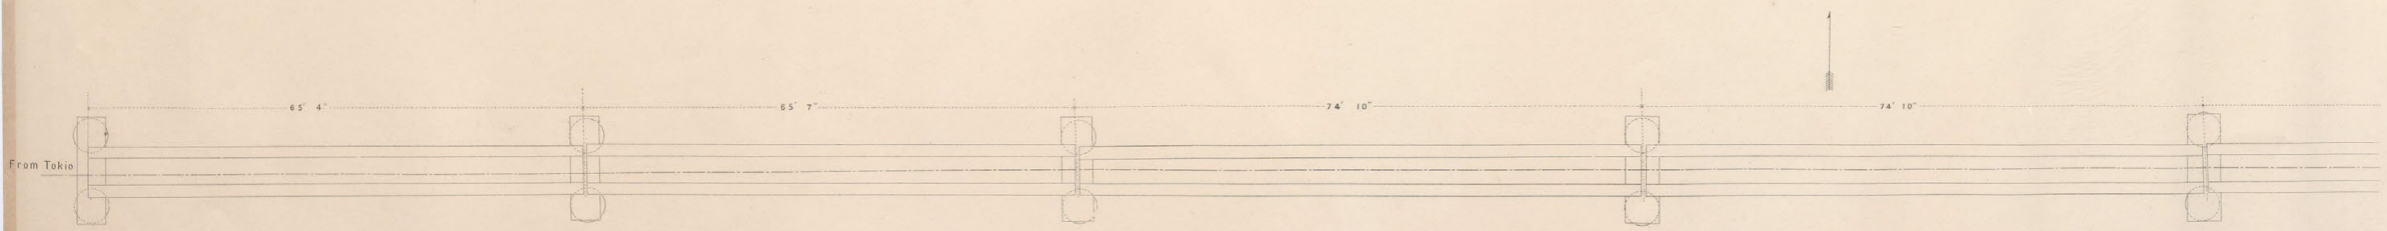
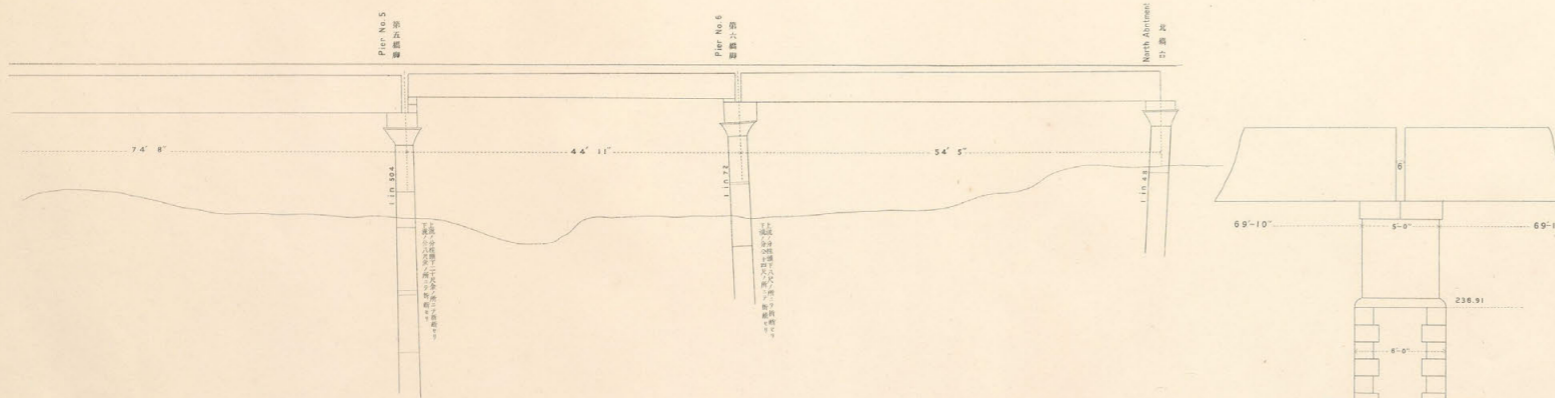
境川橋震害圖(其一)

Showing the condition after the earthquake disaster of Oct. 28th,  
All the piers, each consisting of a couple of cast iron screw piles, 2'6" in diameter and filled with concrete, broken

1891.  
near the surface or underneath the ground.

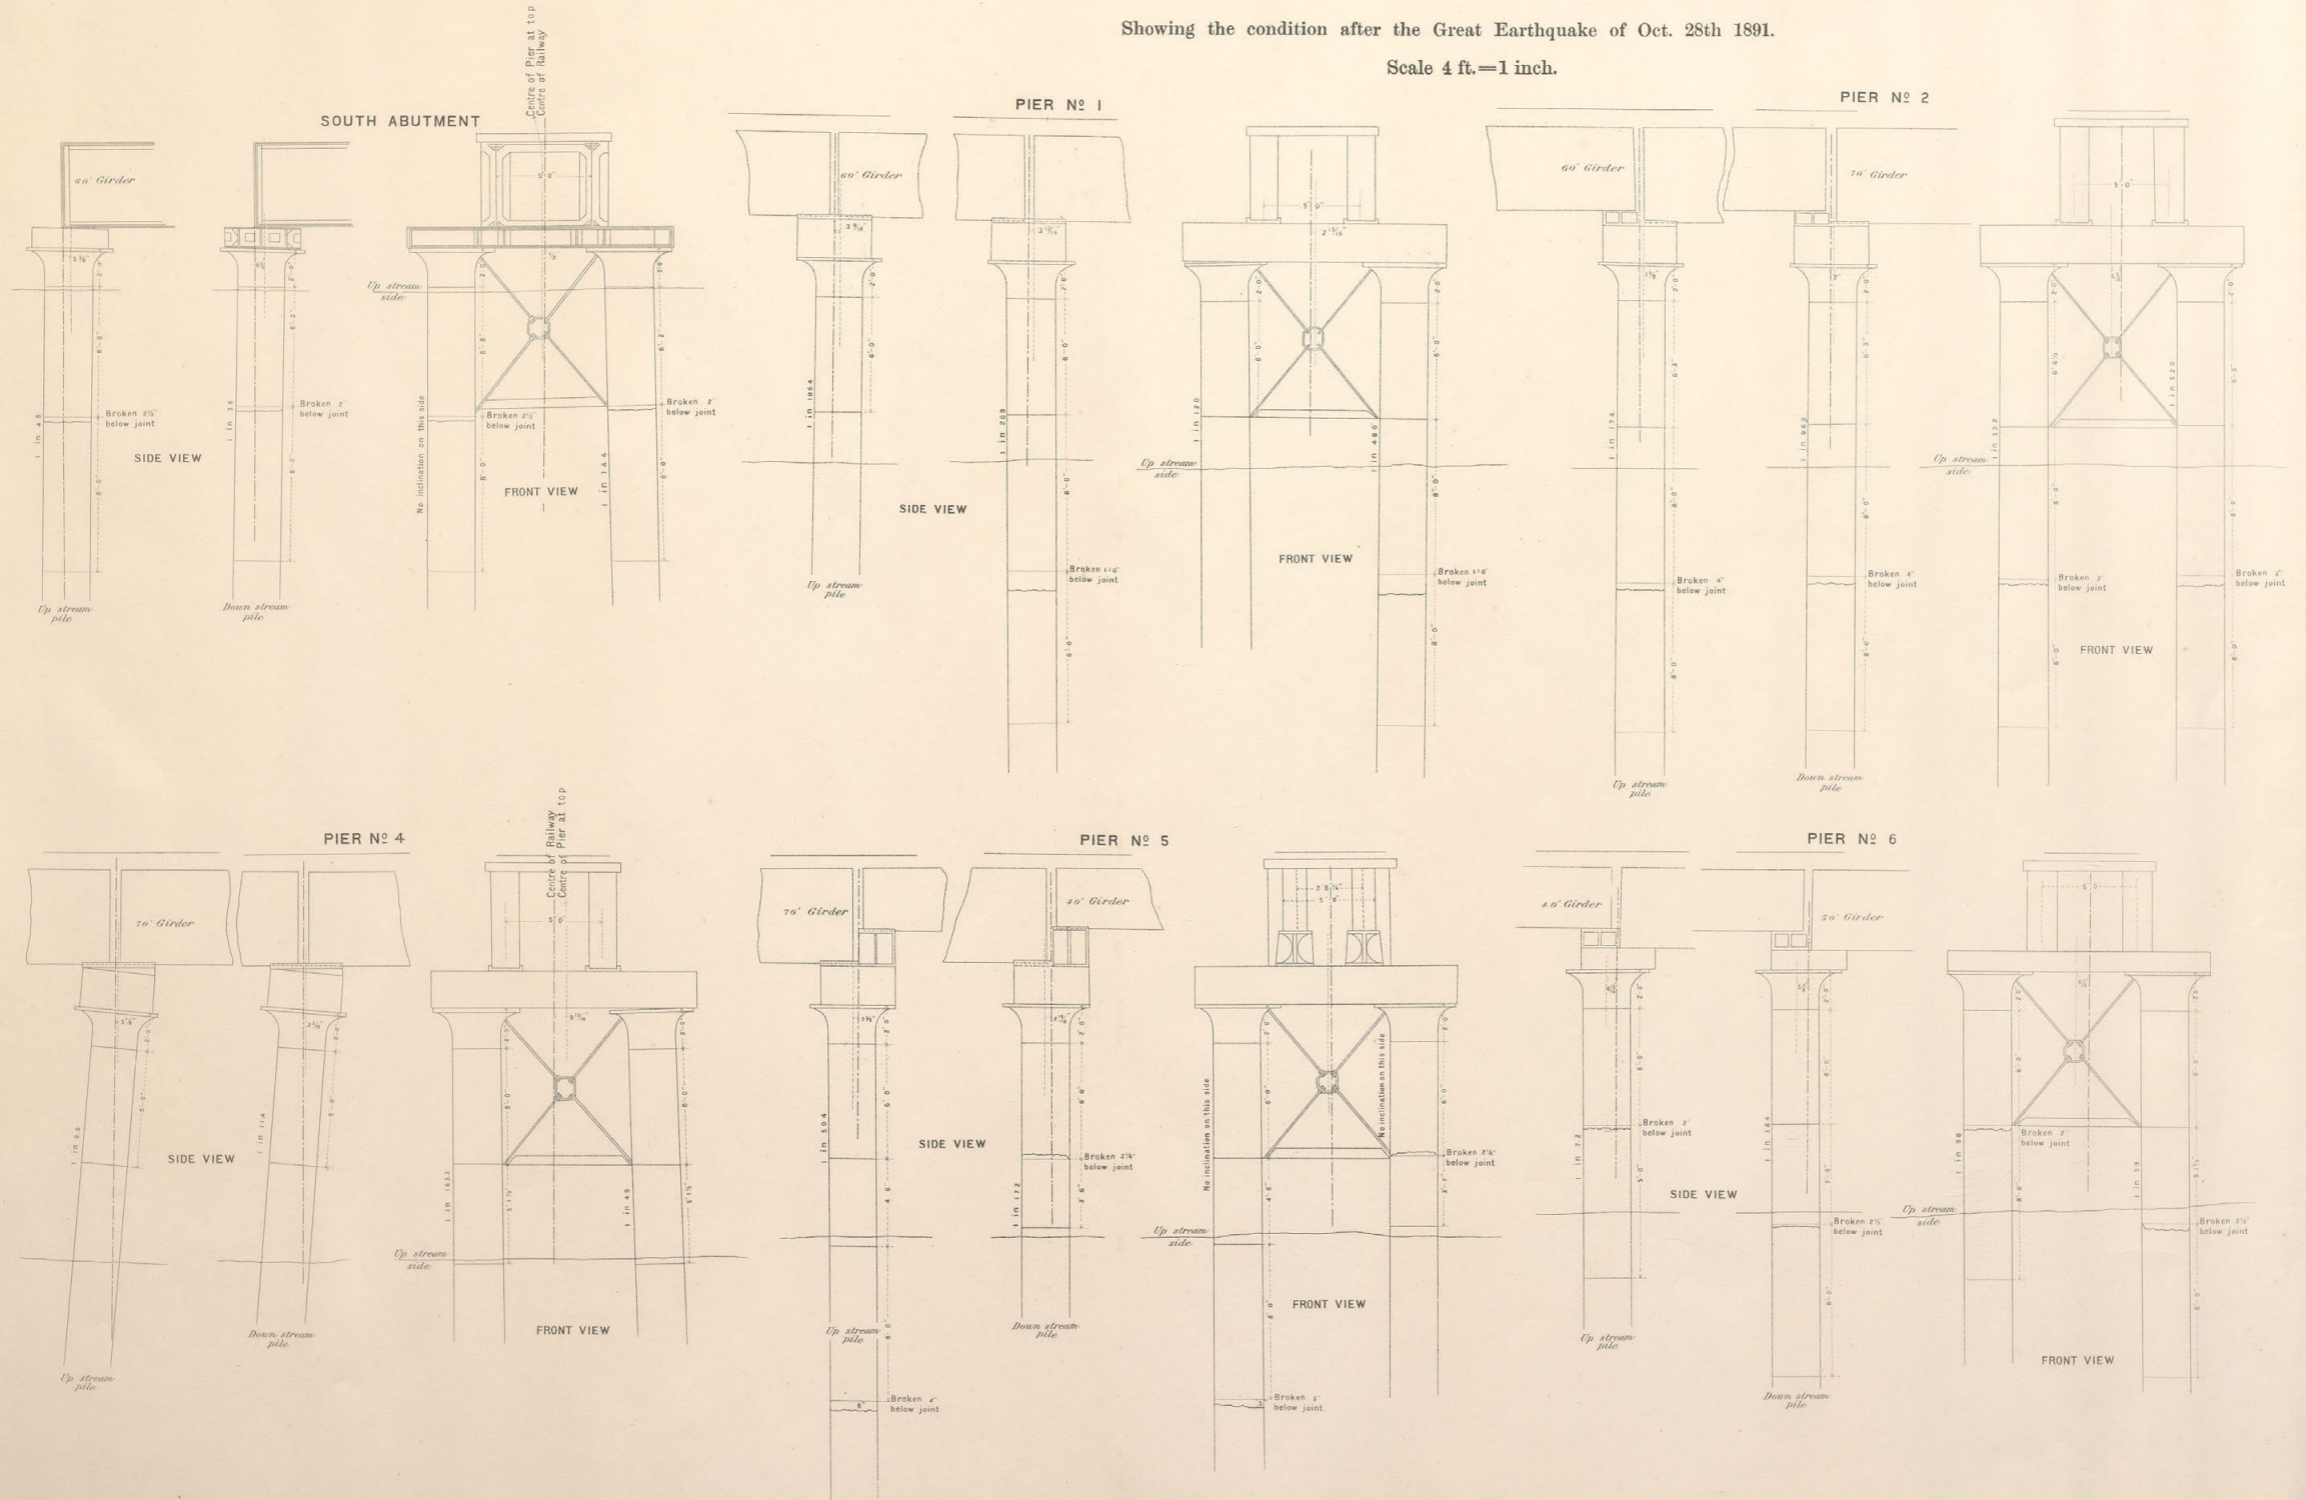
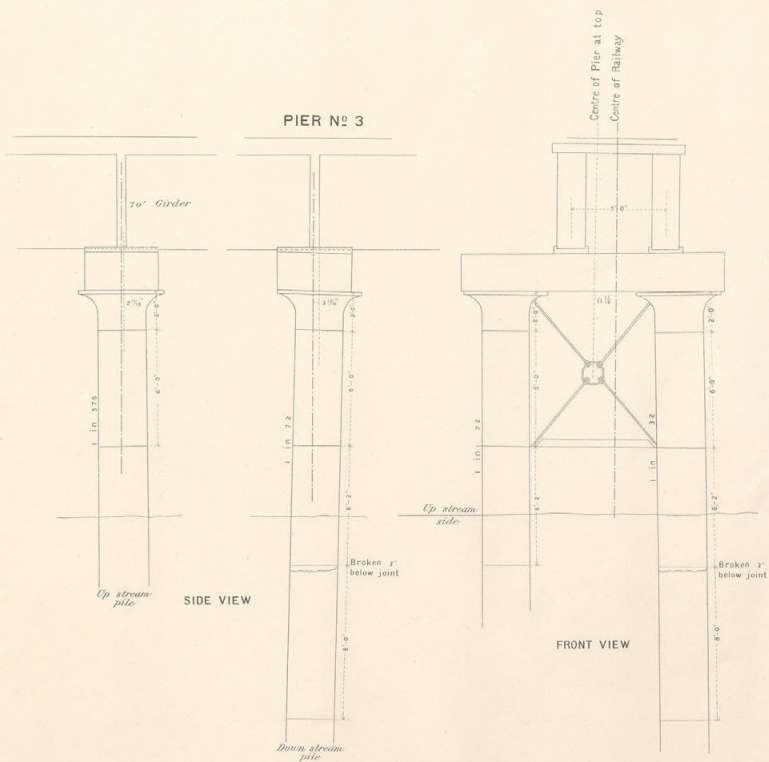
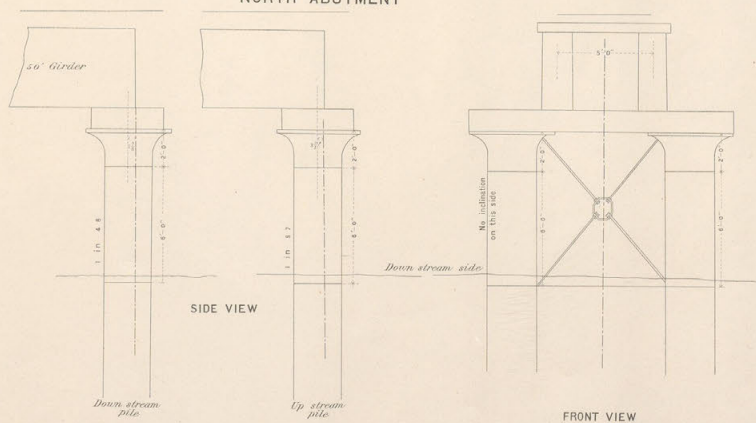
境川橋橋臺及橋脚震害明細圖(其一)

Showing the condition after the Great Earthquake of Oct. 28th 1891.
