震災豫防調査會報告第一號附圖(乙)

五條川橋震害圖及改造橋脚圖	貳枚(其二)
天白川橋震害圖	貳枚(其二)
新川橋震害圖及改造橋脚圖	貳枚(其二)
長良川橋震害圖	貳枚(其二)
長良川橋舊橋脚明細圖	貳枚(其二)
長良川橋改造橋脚圖	壹枚
犀川橋震害圖及改造橋脚圖	貳枚(其二)
揖斐川橋震害圖	壹枚
揖斐川橋橋臺及橋脚震害明細圖	貳枚(其二)
二ノ町コルベルト震害圖	壹枚

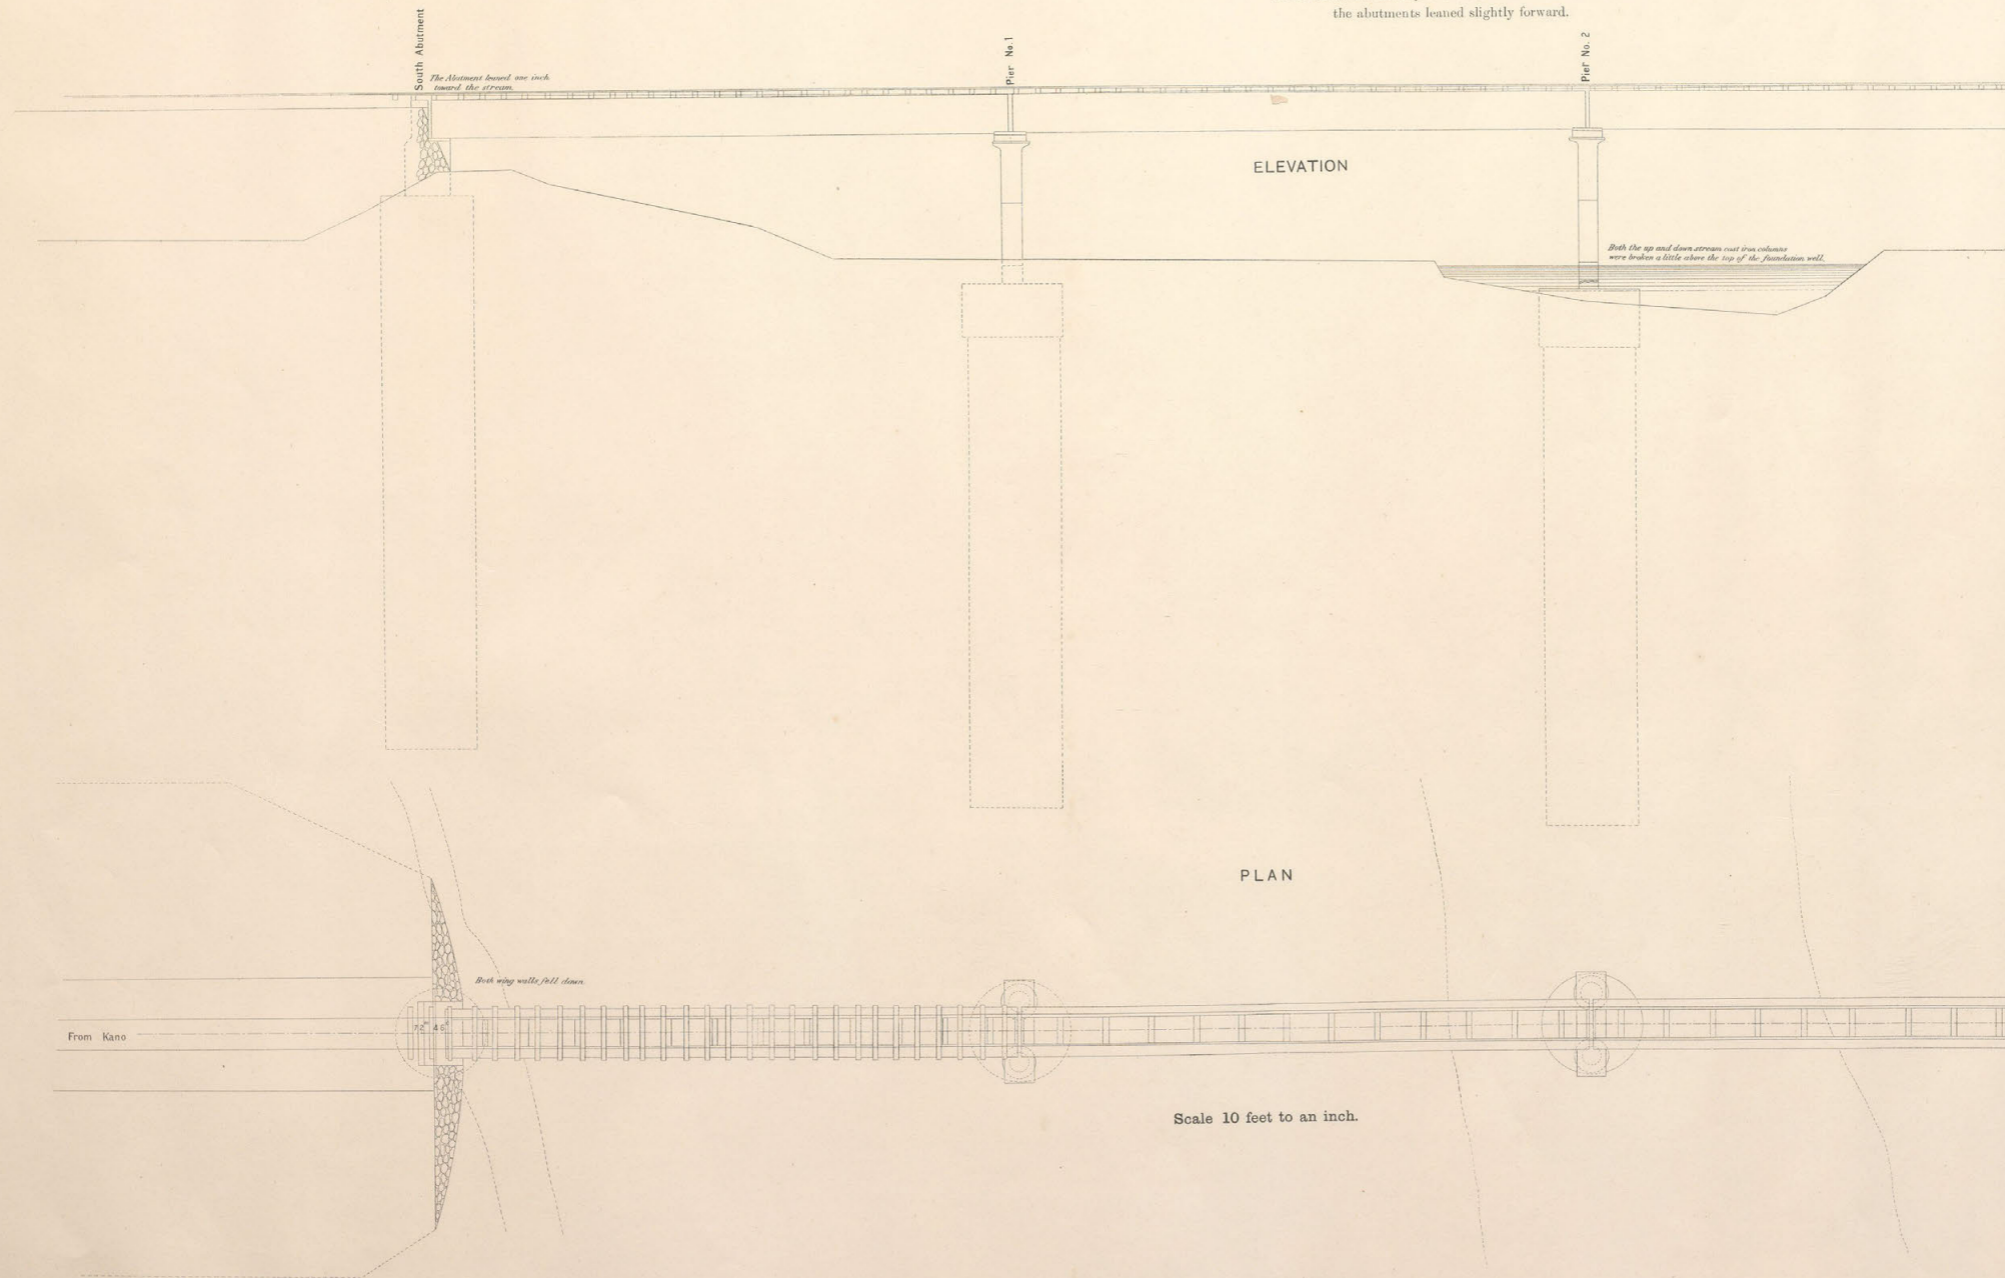
五條川橋震害及改造橋脚圖(其一)

Showing the condition after the great earthquake of Oct. 28th, 1891.

Pier No. 2, consisting of the same pattern as used in Shinkawa Bridge broken at a few feet above the top of the foundation well and one of the abutments leaned slightly forward.

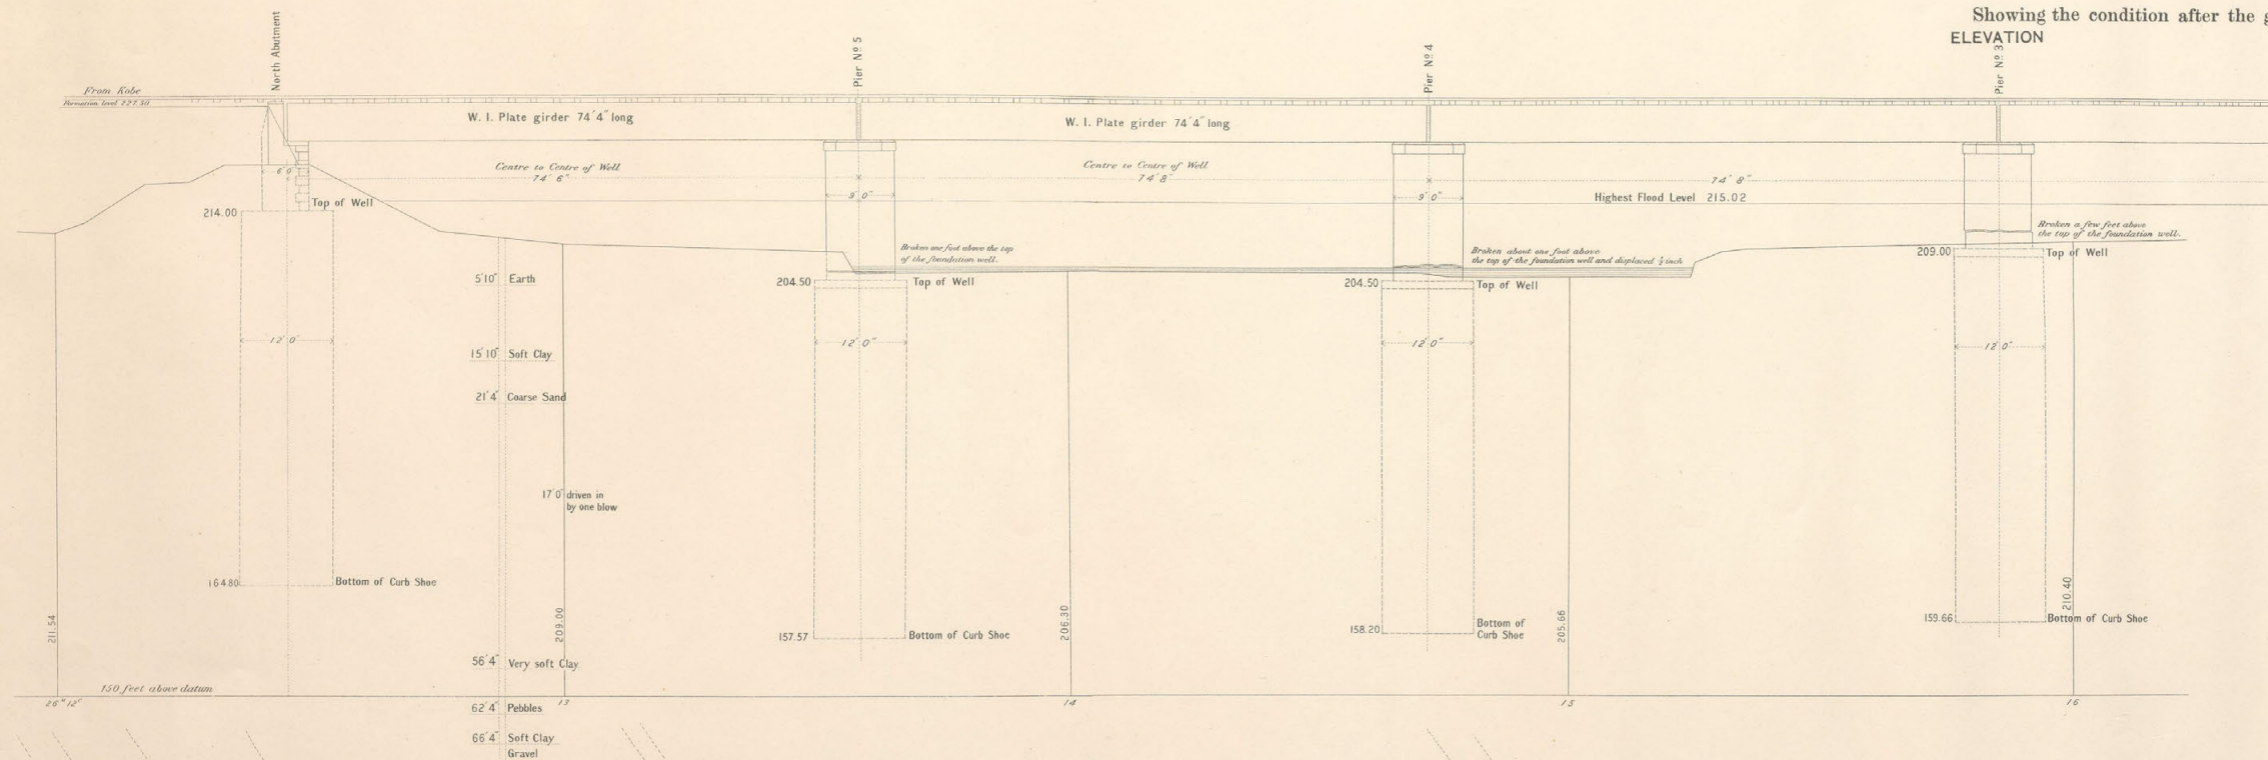
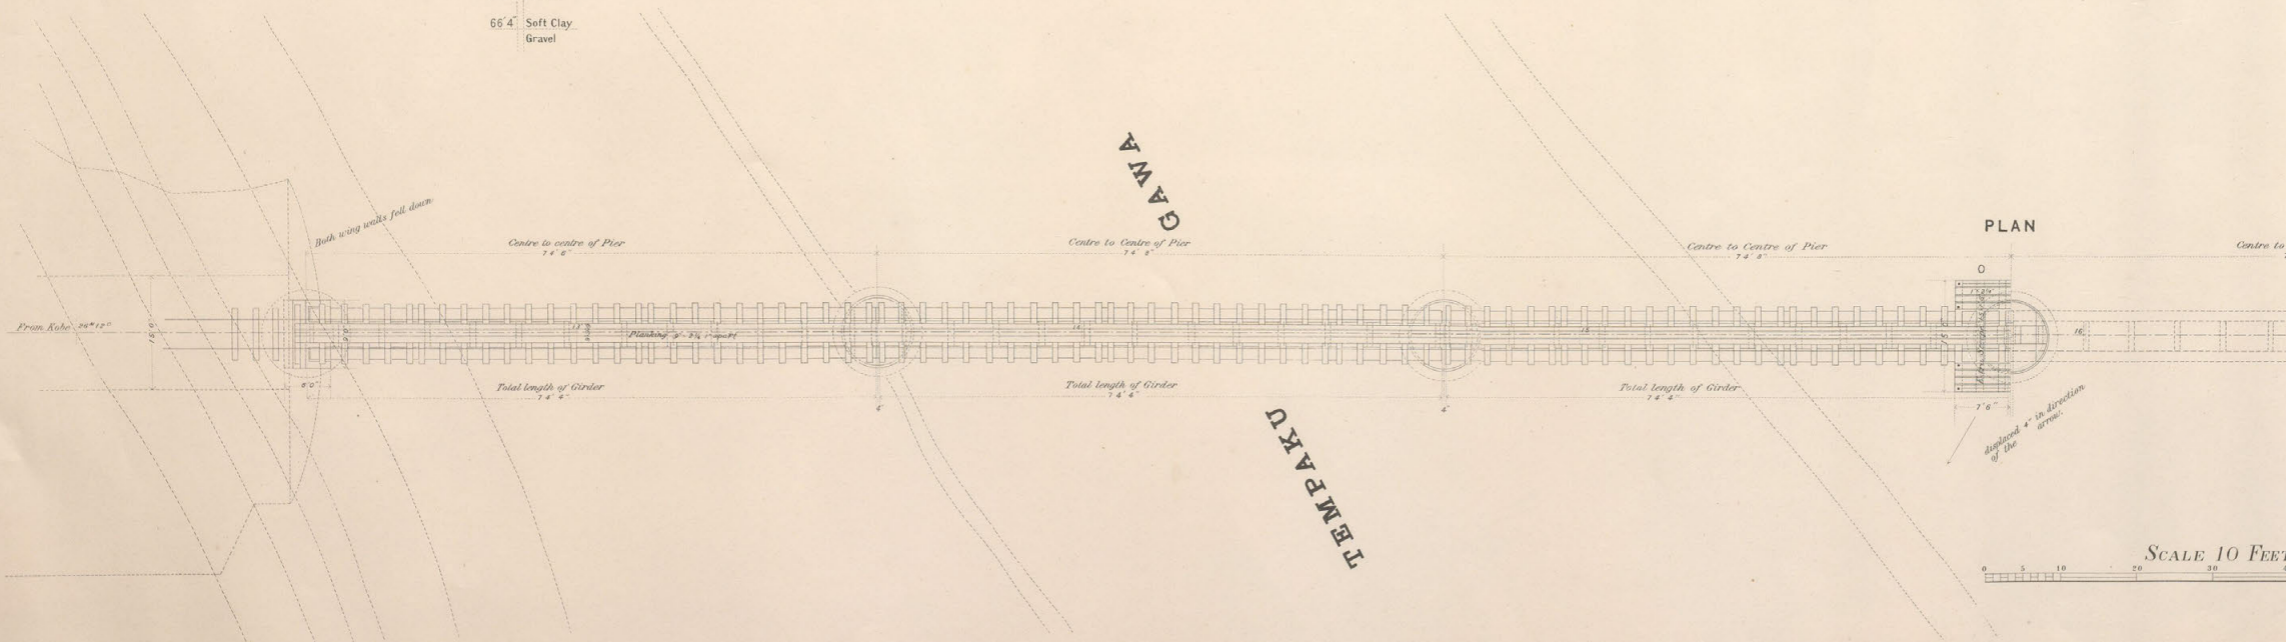
天白川橋震害圖(其二)

eat earthquake of Oct. 28th, 1891.

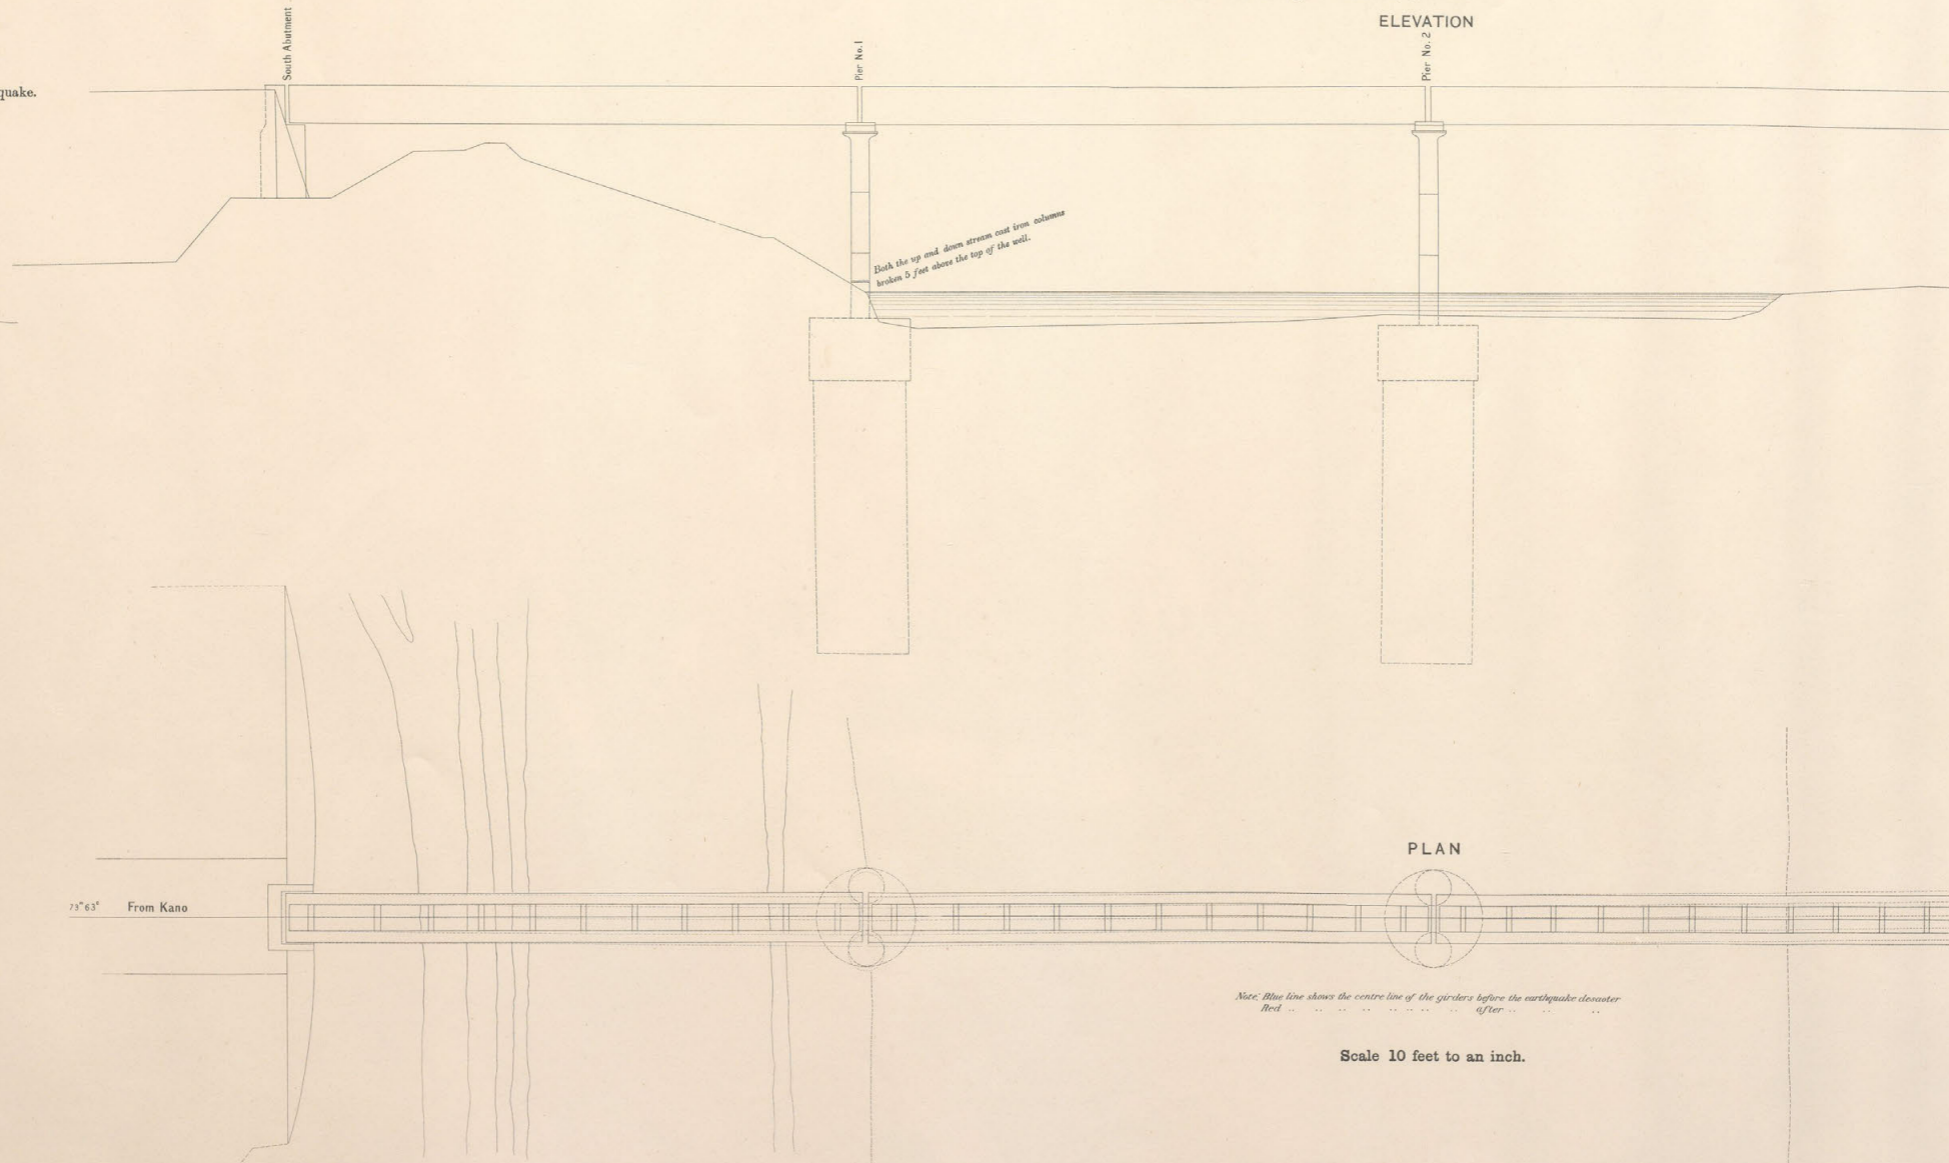
新川橋震害及改造橋脚圖(其一)

Showing the condition after the great earthquake of Oct. 28th, 1891.

Two piers, each consisting of a pair of cast iron columns, 2'6" in diameter, $\frac{1}{2}$ " thick, filled with concrete, broken at a few feet above top of foundation wells and the bridge twisted as shown.

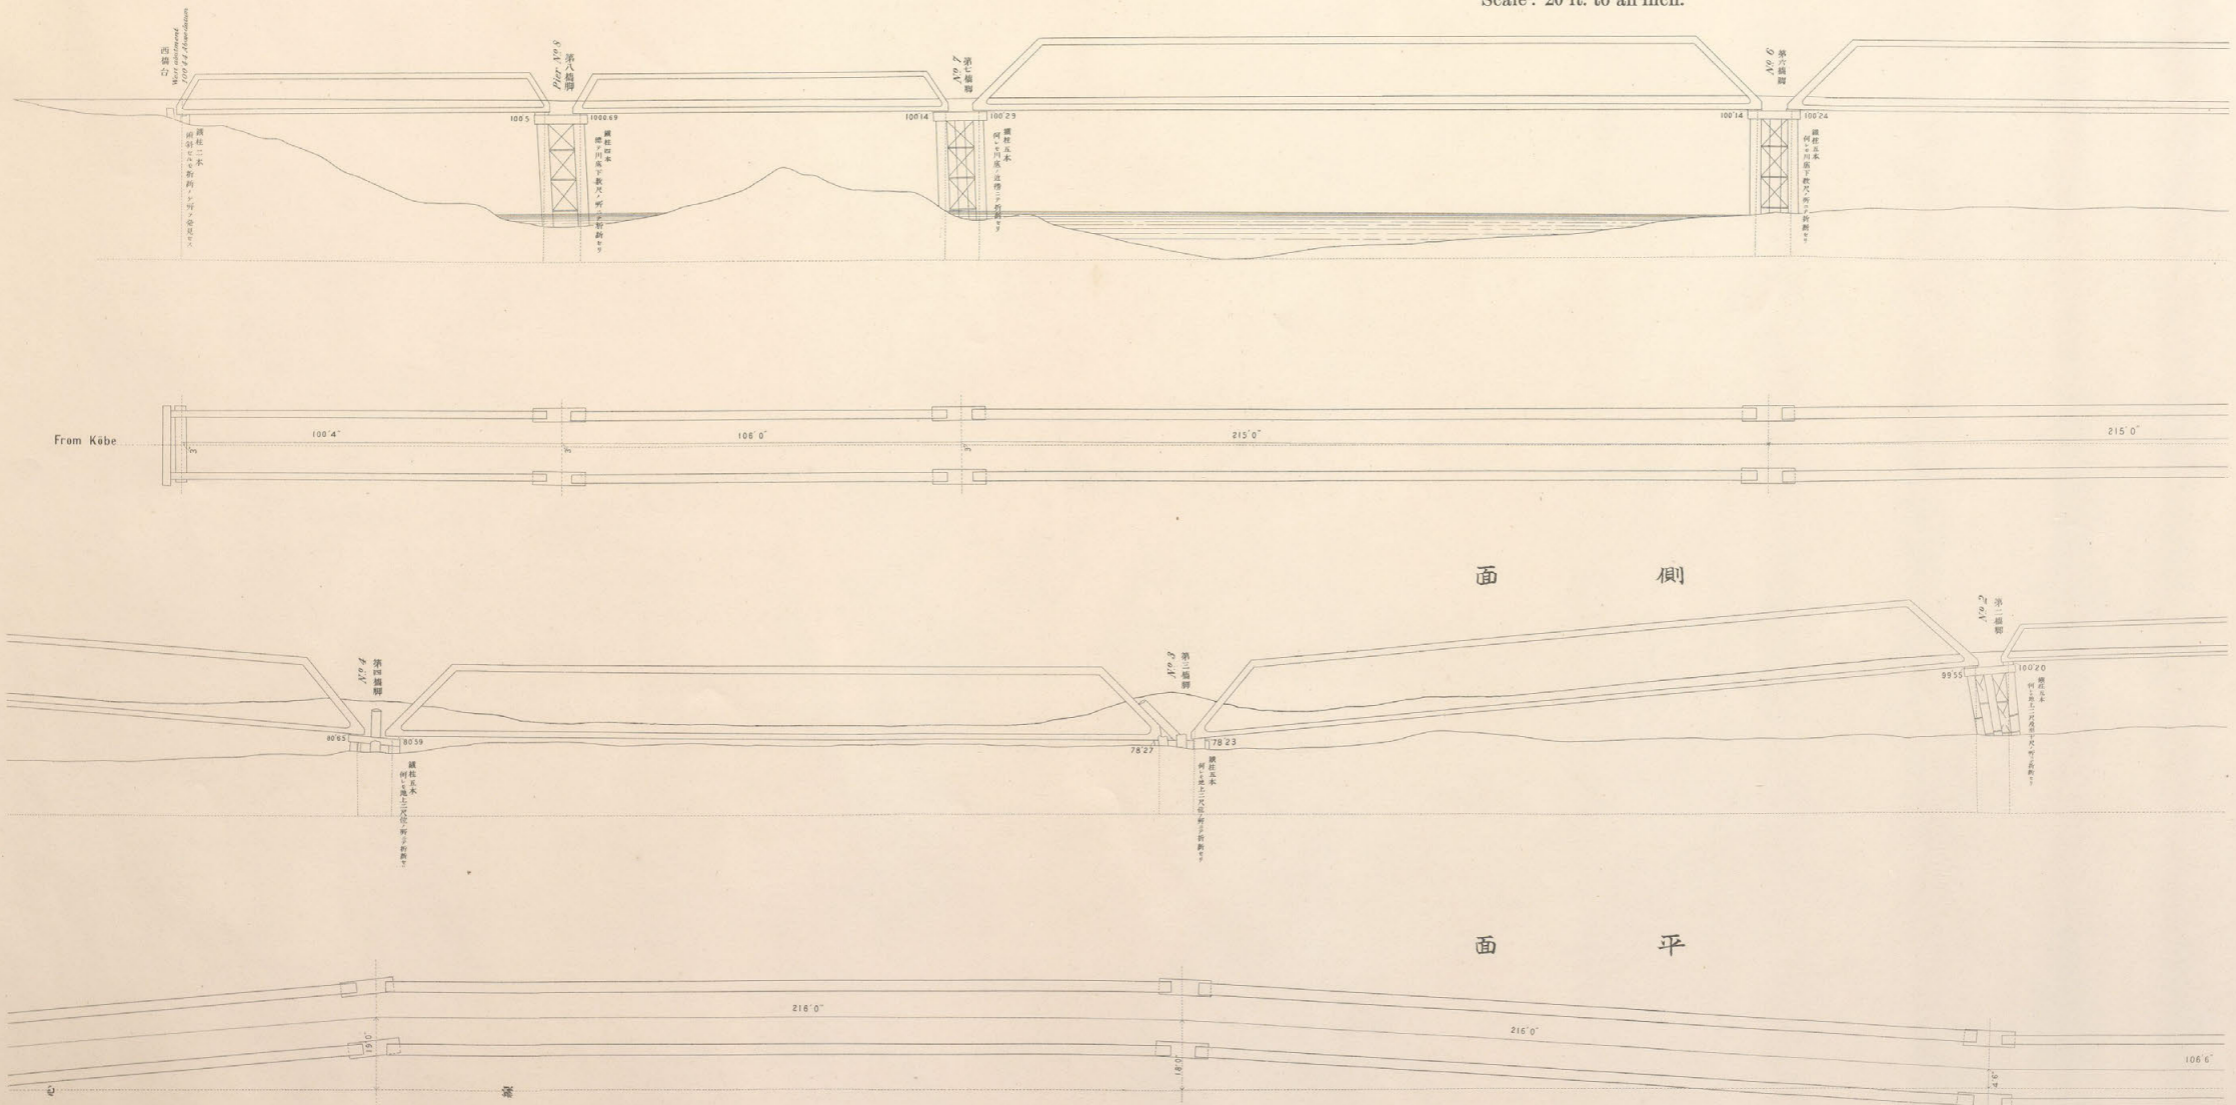
長良川橋震害略圖

Showing the condition after the earthquake disaster of Oct. 28th, 1891.

All piers broken and two piers No. 3 and No. 4 entirely failing. The girders fall down as shown.

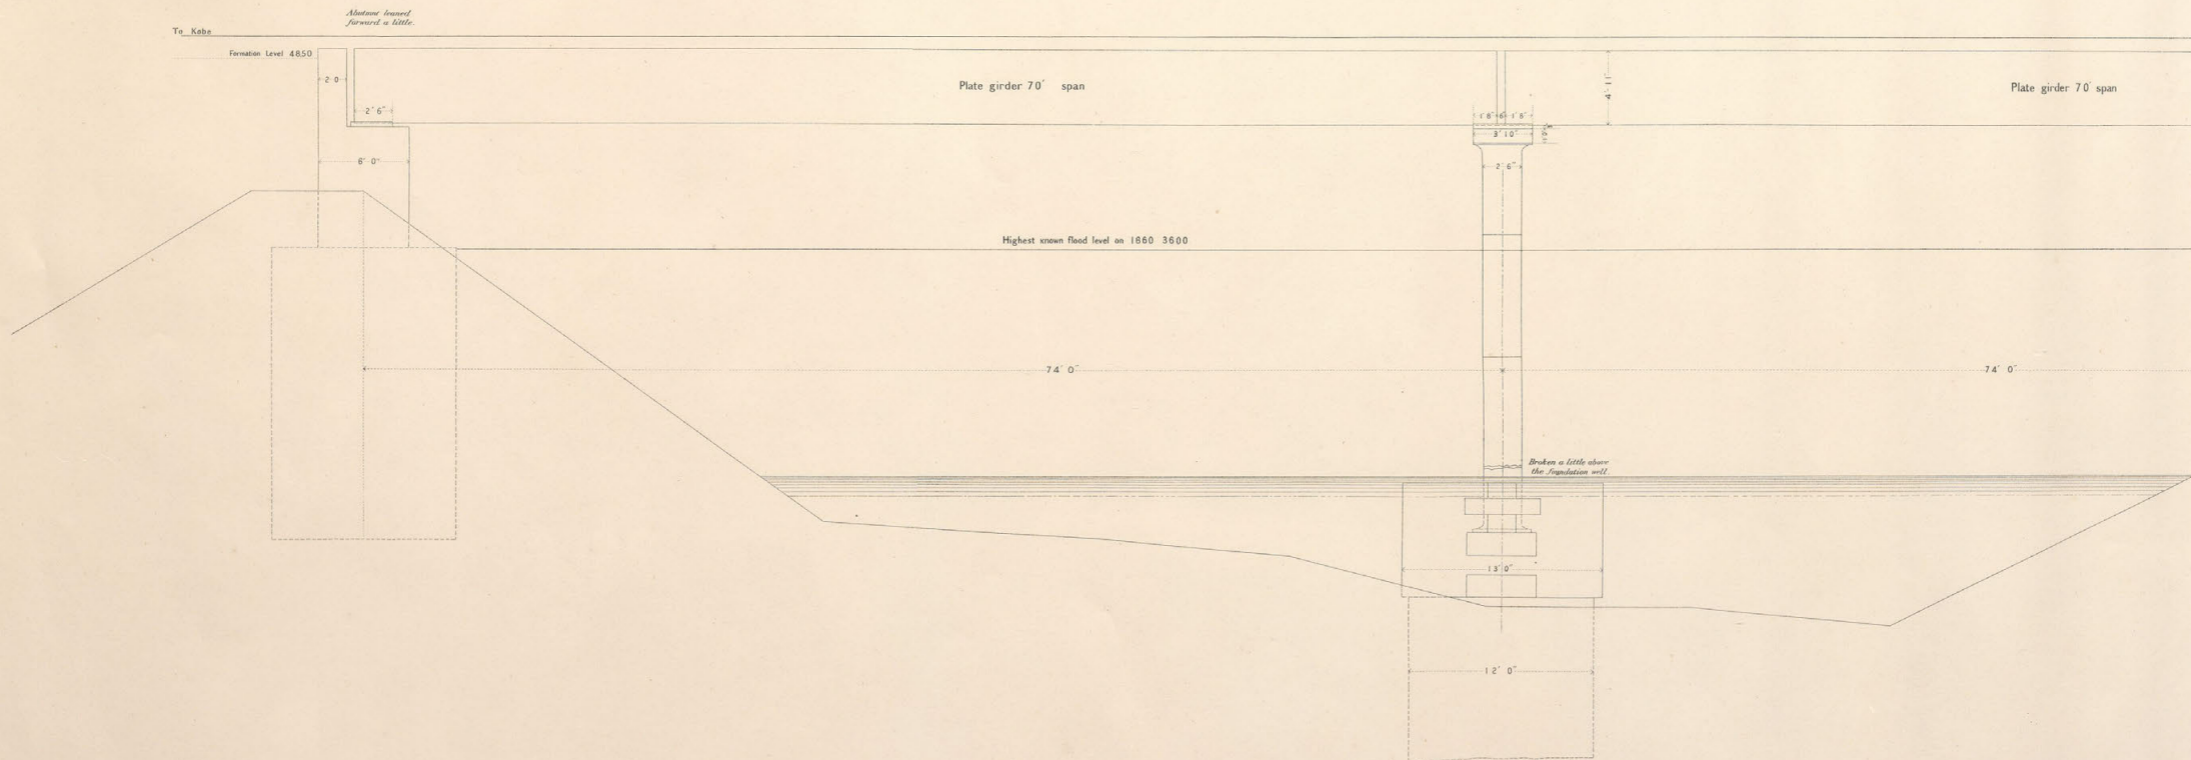
犀川橋震害圖及改造橋脚圖(其一)

Showing
 The condition after the earthquake disaster of Oct. 28th, 1891.

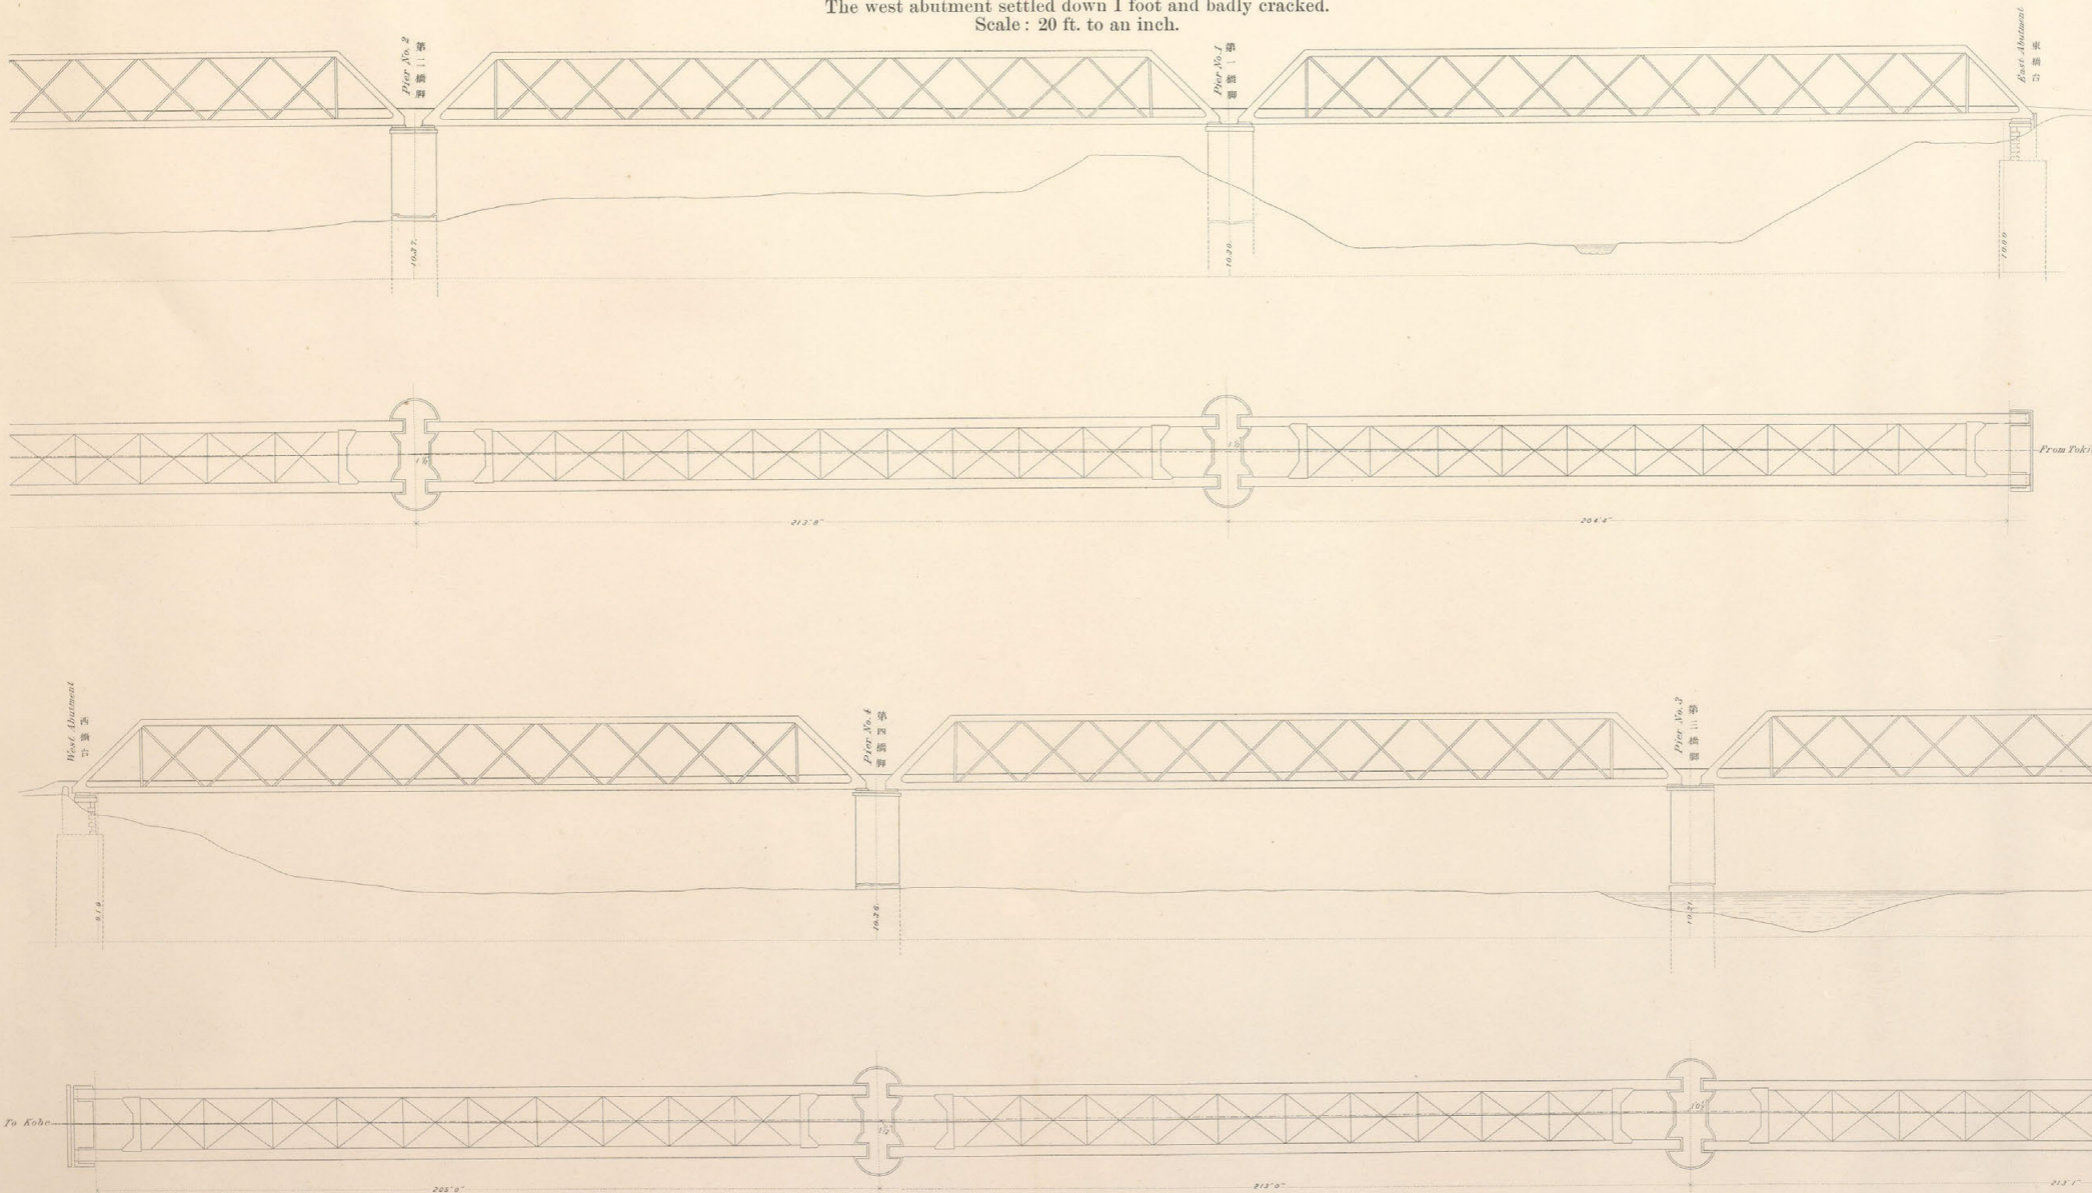
圖 害 震 橋 川 斐 捐
 ELEVATION AND PLAN
 OF
 IBIGAWA BRIDGE.

Showing the condition after the earthquake disaster of Oct. 28th, 1891.
 All the piers, each consisting of a pair of brick columns, 12' in diameter, broken a few feet above low water level and displaced a few inches in various directions.
 The west abutment settled down 1 foot and badly cracked.
 Scale: 20 ft. to an inch.

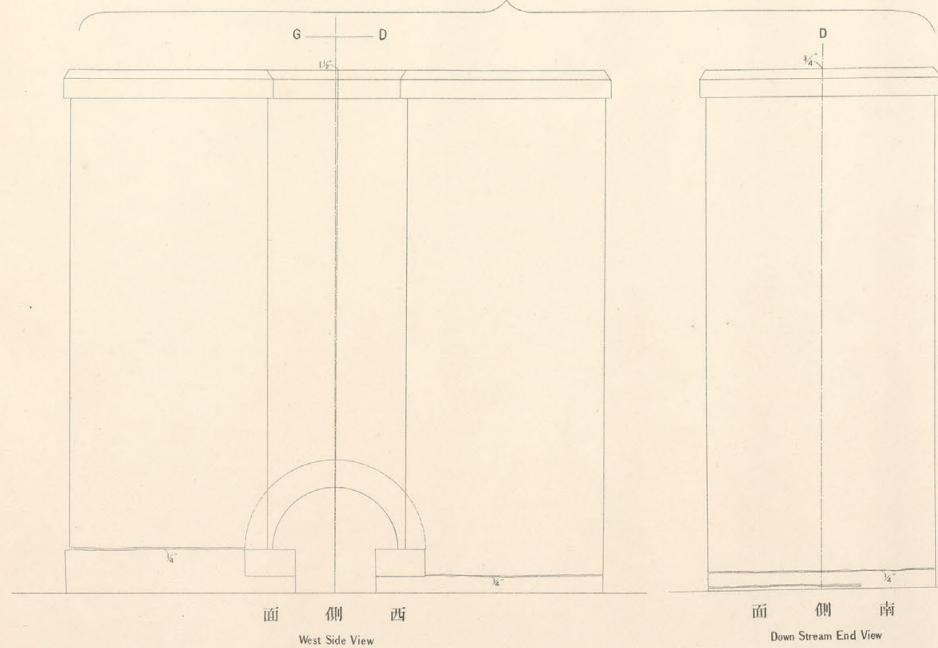
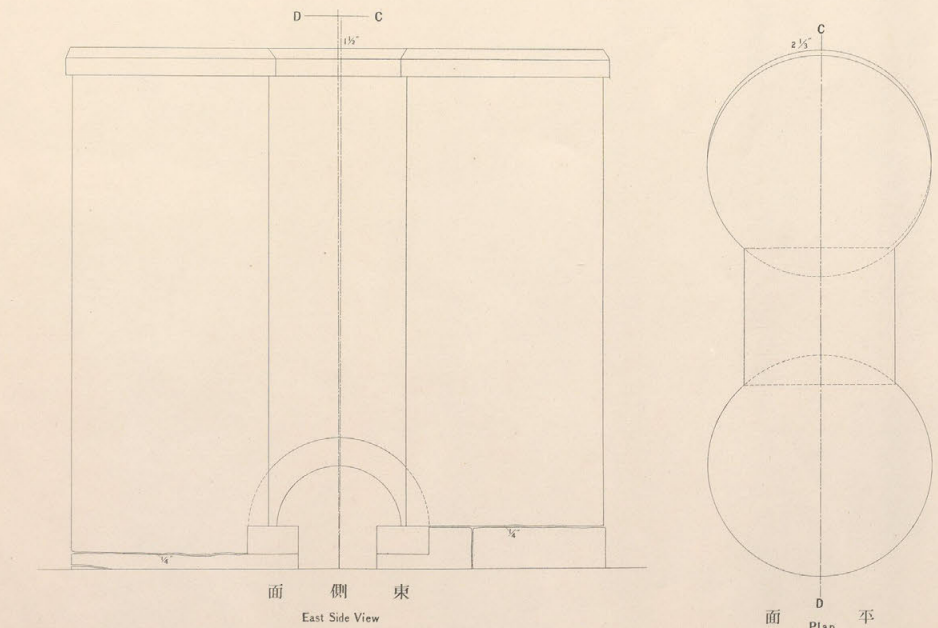
Pier No. 4.
脚橋四第

Showing the condition after the earth

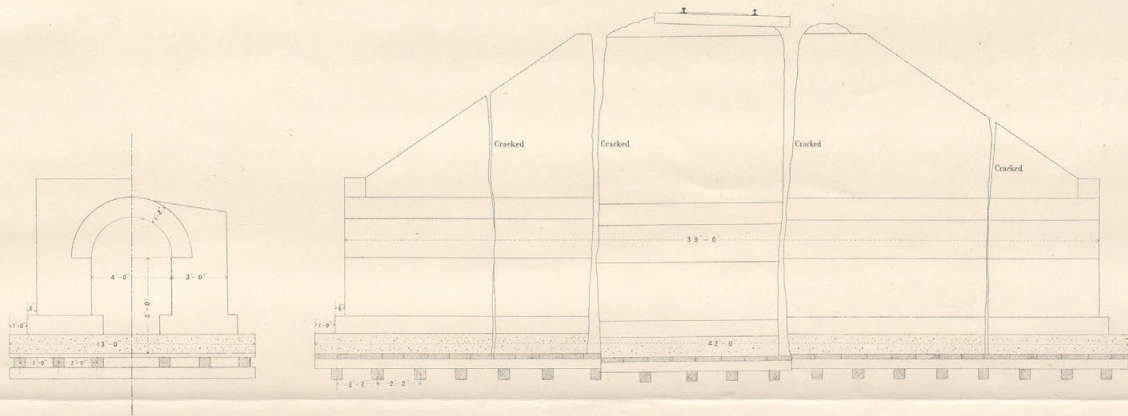
NINOMACHI CULVERT.

Showing the condition after the great earthquake disaster of Oct. 28th, 1891.

The embankment and the culvert cracked through as shown.
