# 震災豫防調査會報告第一號附圖(甲)

東海道鐵道線路大府大垣間平面圖	六枚 (自其一 至其六)
東海道枝線大府武豐間平面圖	貳枚 (其一)
木曾川橋震害圖	貳枚 (其二)
木曾川橋改造橋脚圖	壹枚
舊木曾川鐵橋橋臺及橋脚圖	壹枚
境川橋震害圖	貳枚 (其三)
境川橋橋臺及橋脚震害明細圖	貳枚 (其二)

# 東海道鐵道線路大府大垣間平面圖

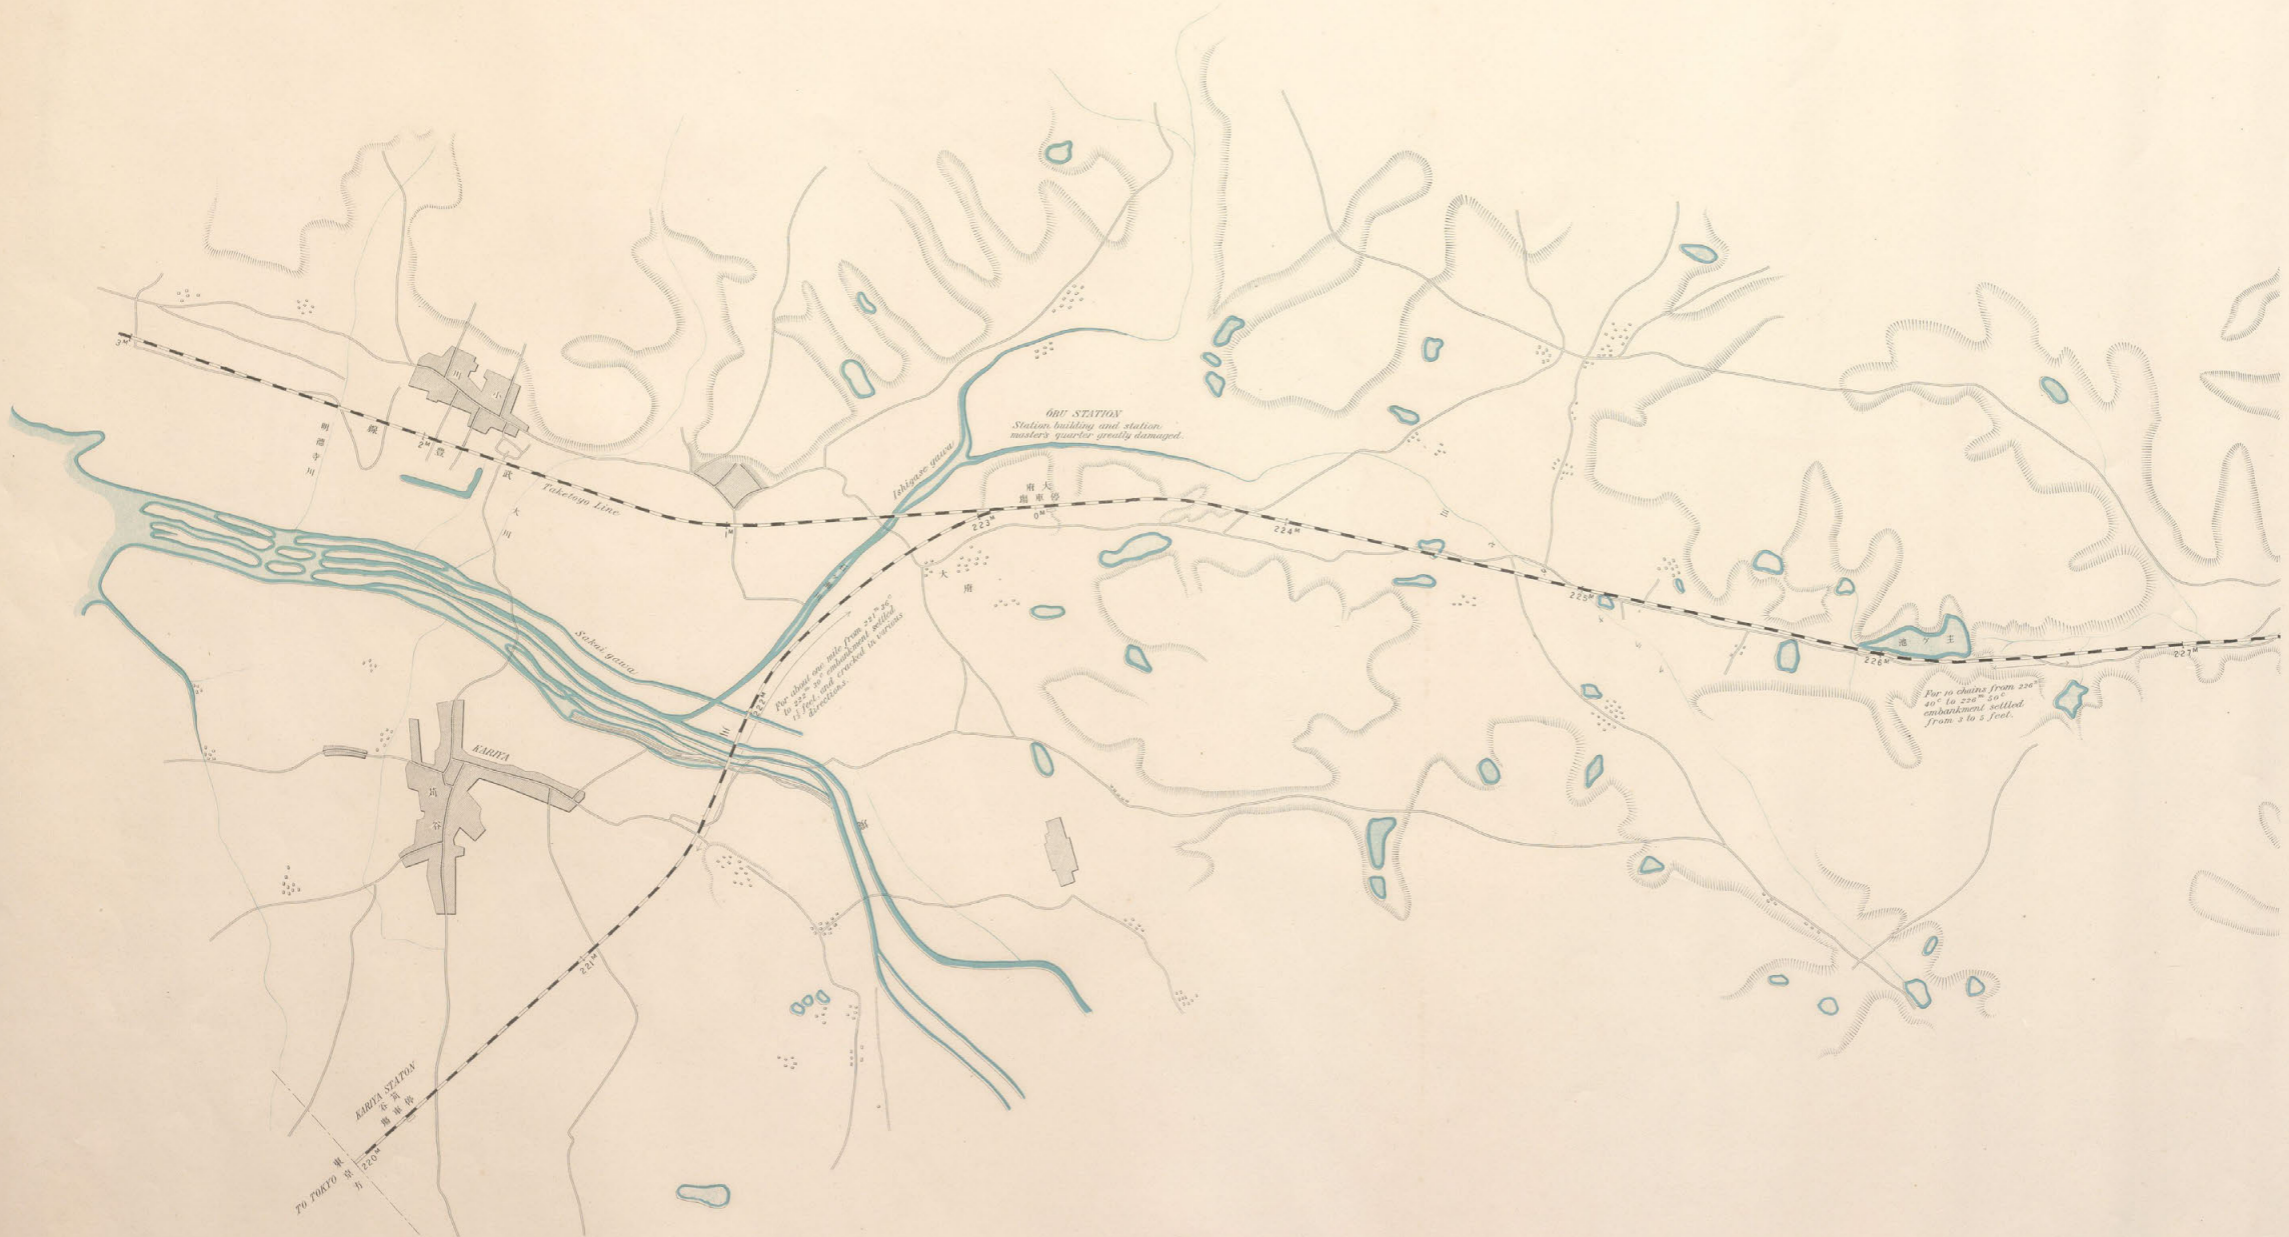
東海道鐵道線路大府大垣間平面圖(其一)

Tombakugawa Bridge (6-75 spans)  
All the piers broken also the feet  
above the foundations well and some  
of them displaced a few inches as  
shown in the detail drawing.

For 23 chains from 220° 25' to  
230° 25' embankment settled  
from 1 to 4 feet.

For 23 chains from 220° 25' to  
230° 25' embankment settled  
about 4 feet.

AIZUTA STATION.  
Station building entirely fell down.  
Station master's quarters partly fell down.  
Up platform settled down 7 or 8 feet.  
Other buildings damaged more or less.
