震災豫防調査會報告第一號附圖(乙)

五條川橋震害圖及改造橋脚圖	貳枚(其二)
天白川橋震害圖	貳枚(其二)
新川橋震害圖及改造橋脚圖	貳枚(其二)
長良川橋震害圖	貳枚(其二)
長良川橋舊橋脚明細圖	貳枚(其二)
長良川橋改造橋脚圖	壹枚
犀川橋震害圖及改造橋脚圖	貳枚(其二)
揖斐川橋震害圖	壹枚
揖斐川橋橋臺及橋脚震害明細圖	貳枚(其二)
二ノ町コルベルト震害圖	壹枚

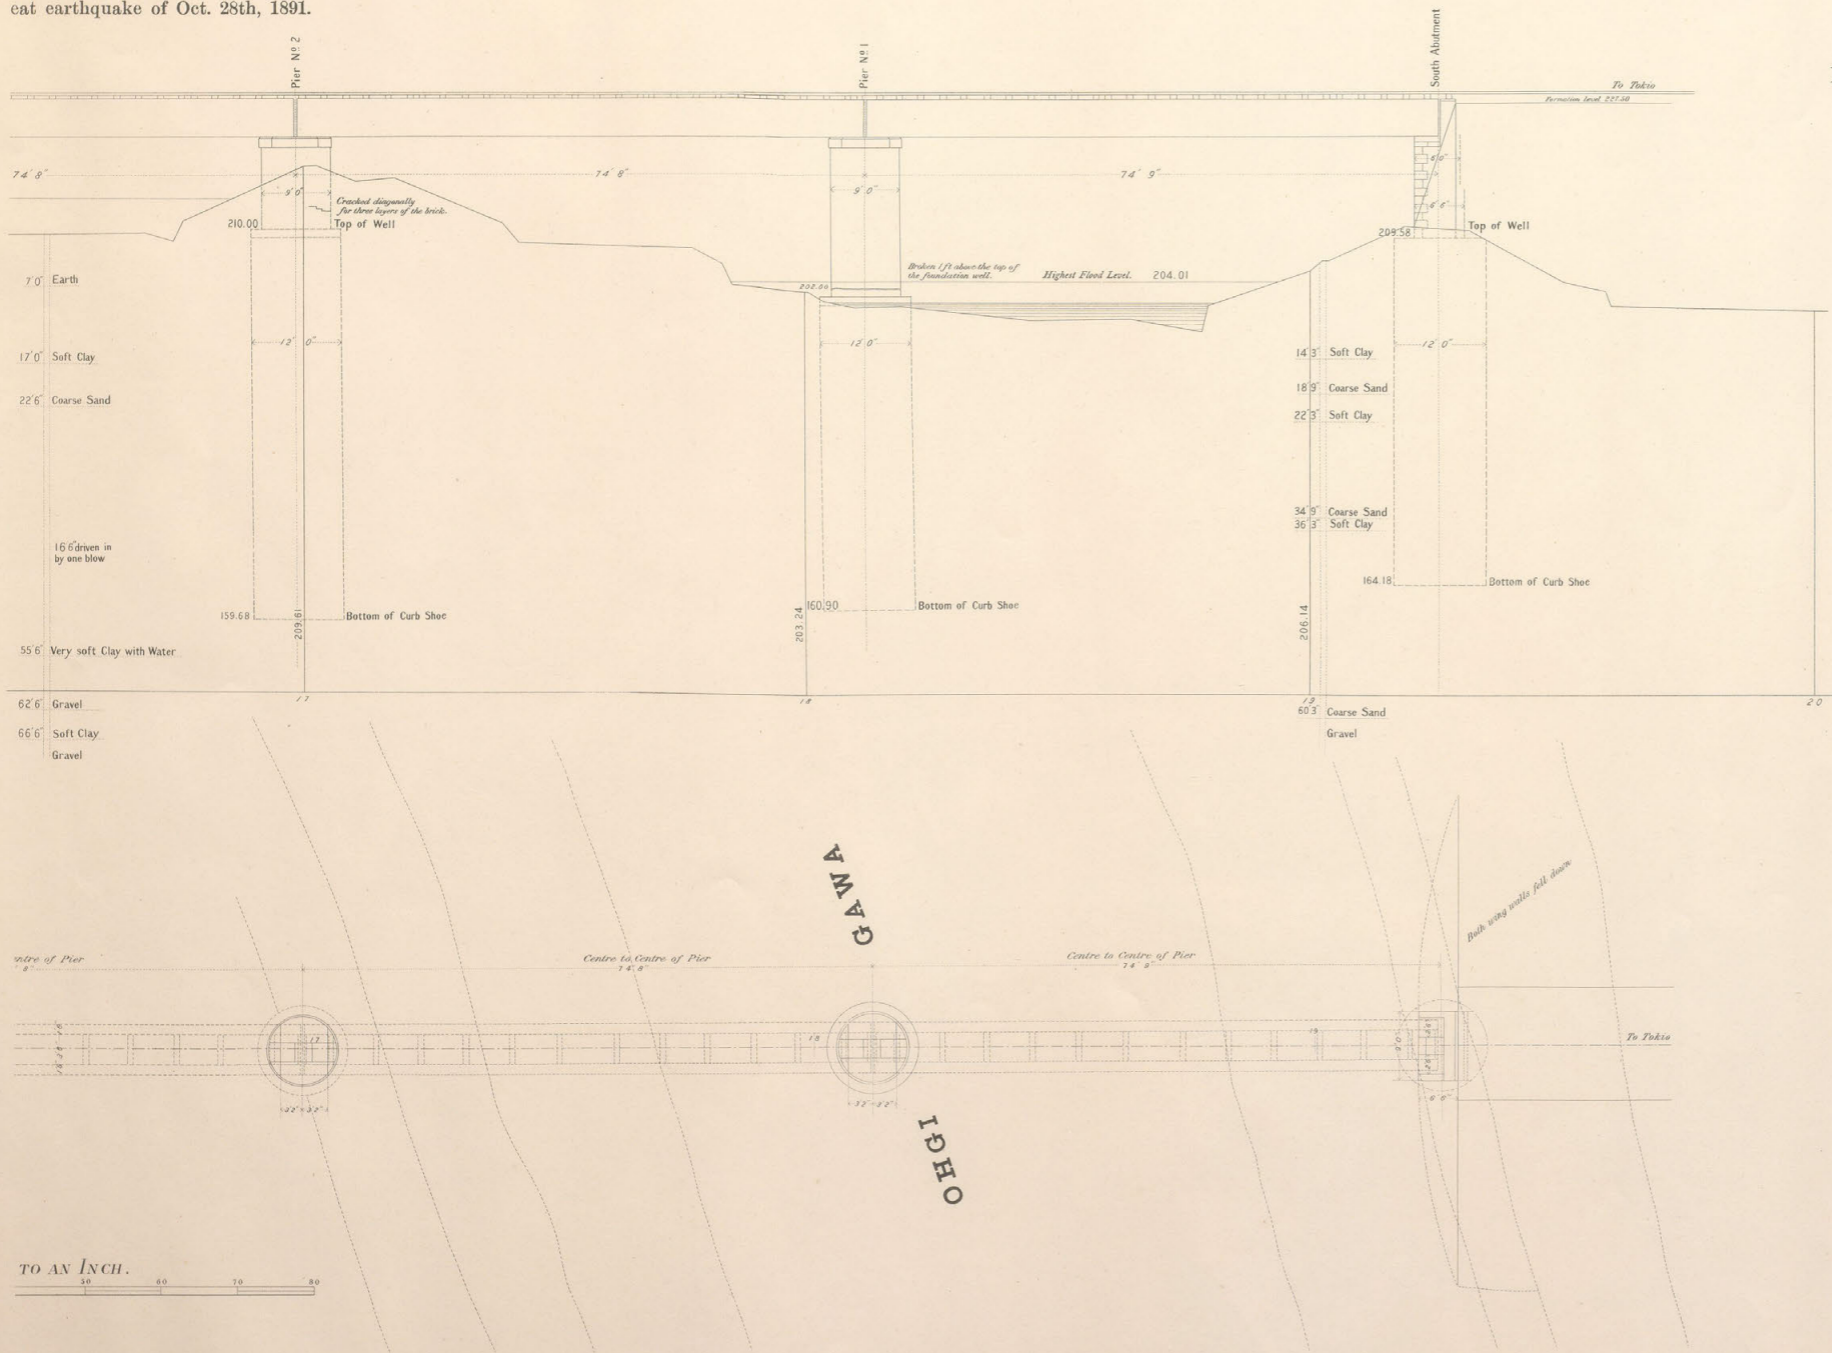
天白川橋震害圖(其二)

Showing the condition after the gr
ELEVATION

eat earthquake of Oct. 28th, 1891.

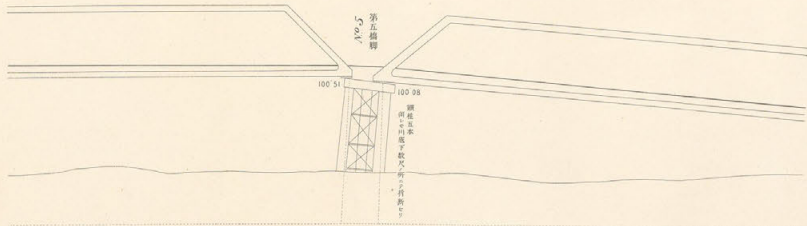
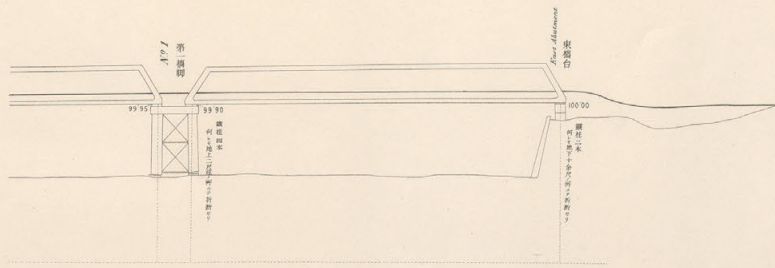
長良川橋震害圖(其二)

Showing the condition after the earthquake disaster of Oct. 28th, 1891.

All piers broken and two piers No. 3 and No. 4 entirely failing. The girders fall down as shown.

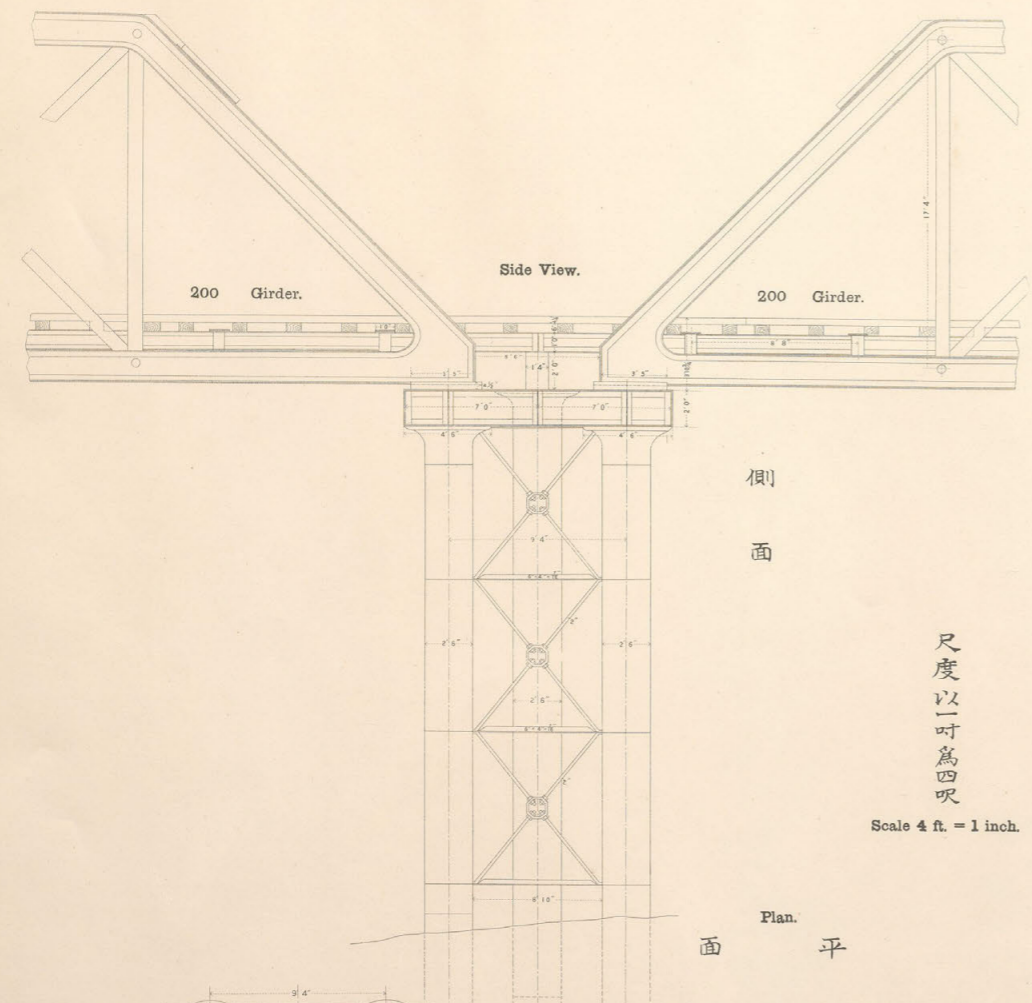
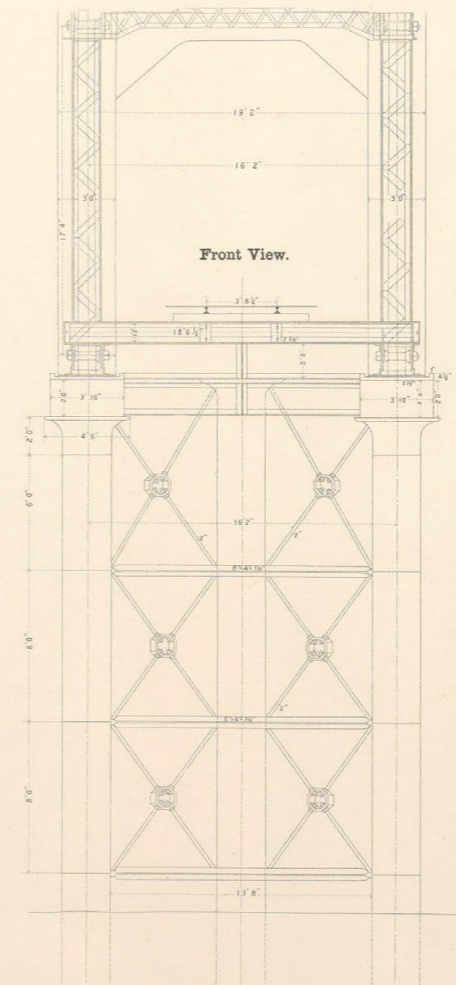
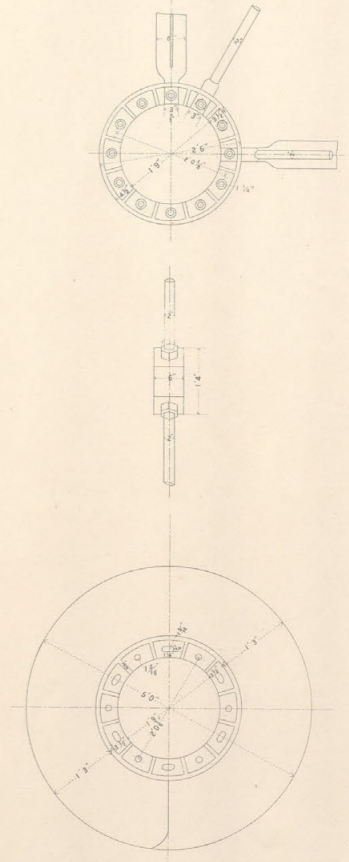
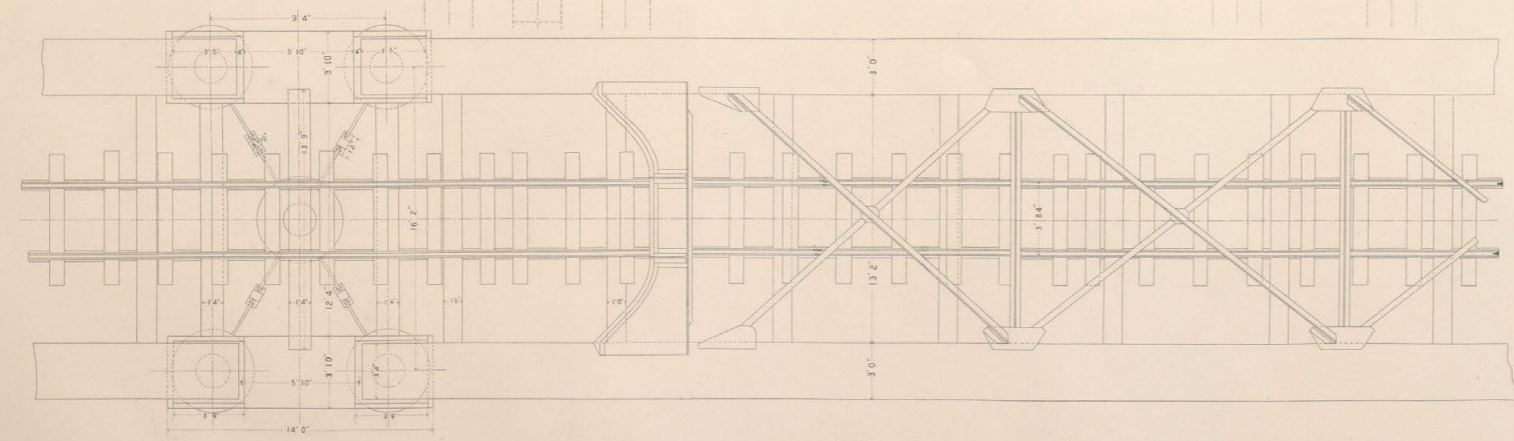
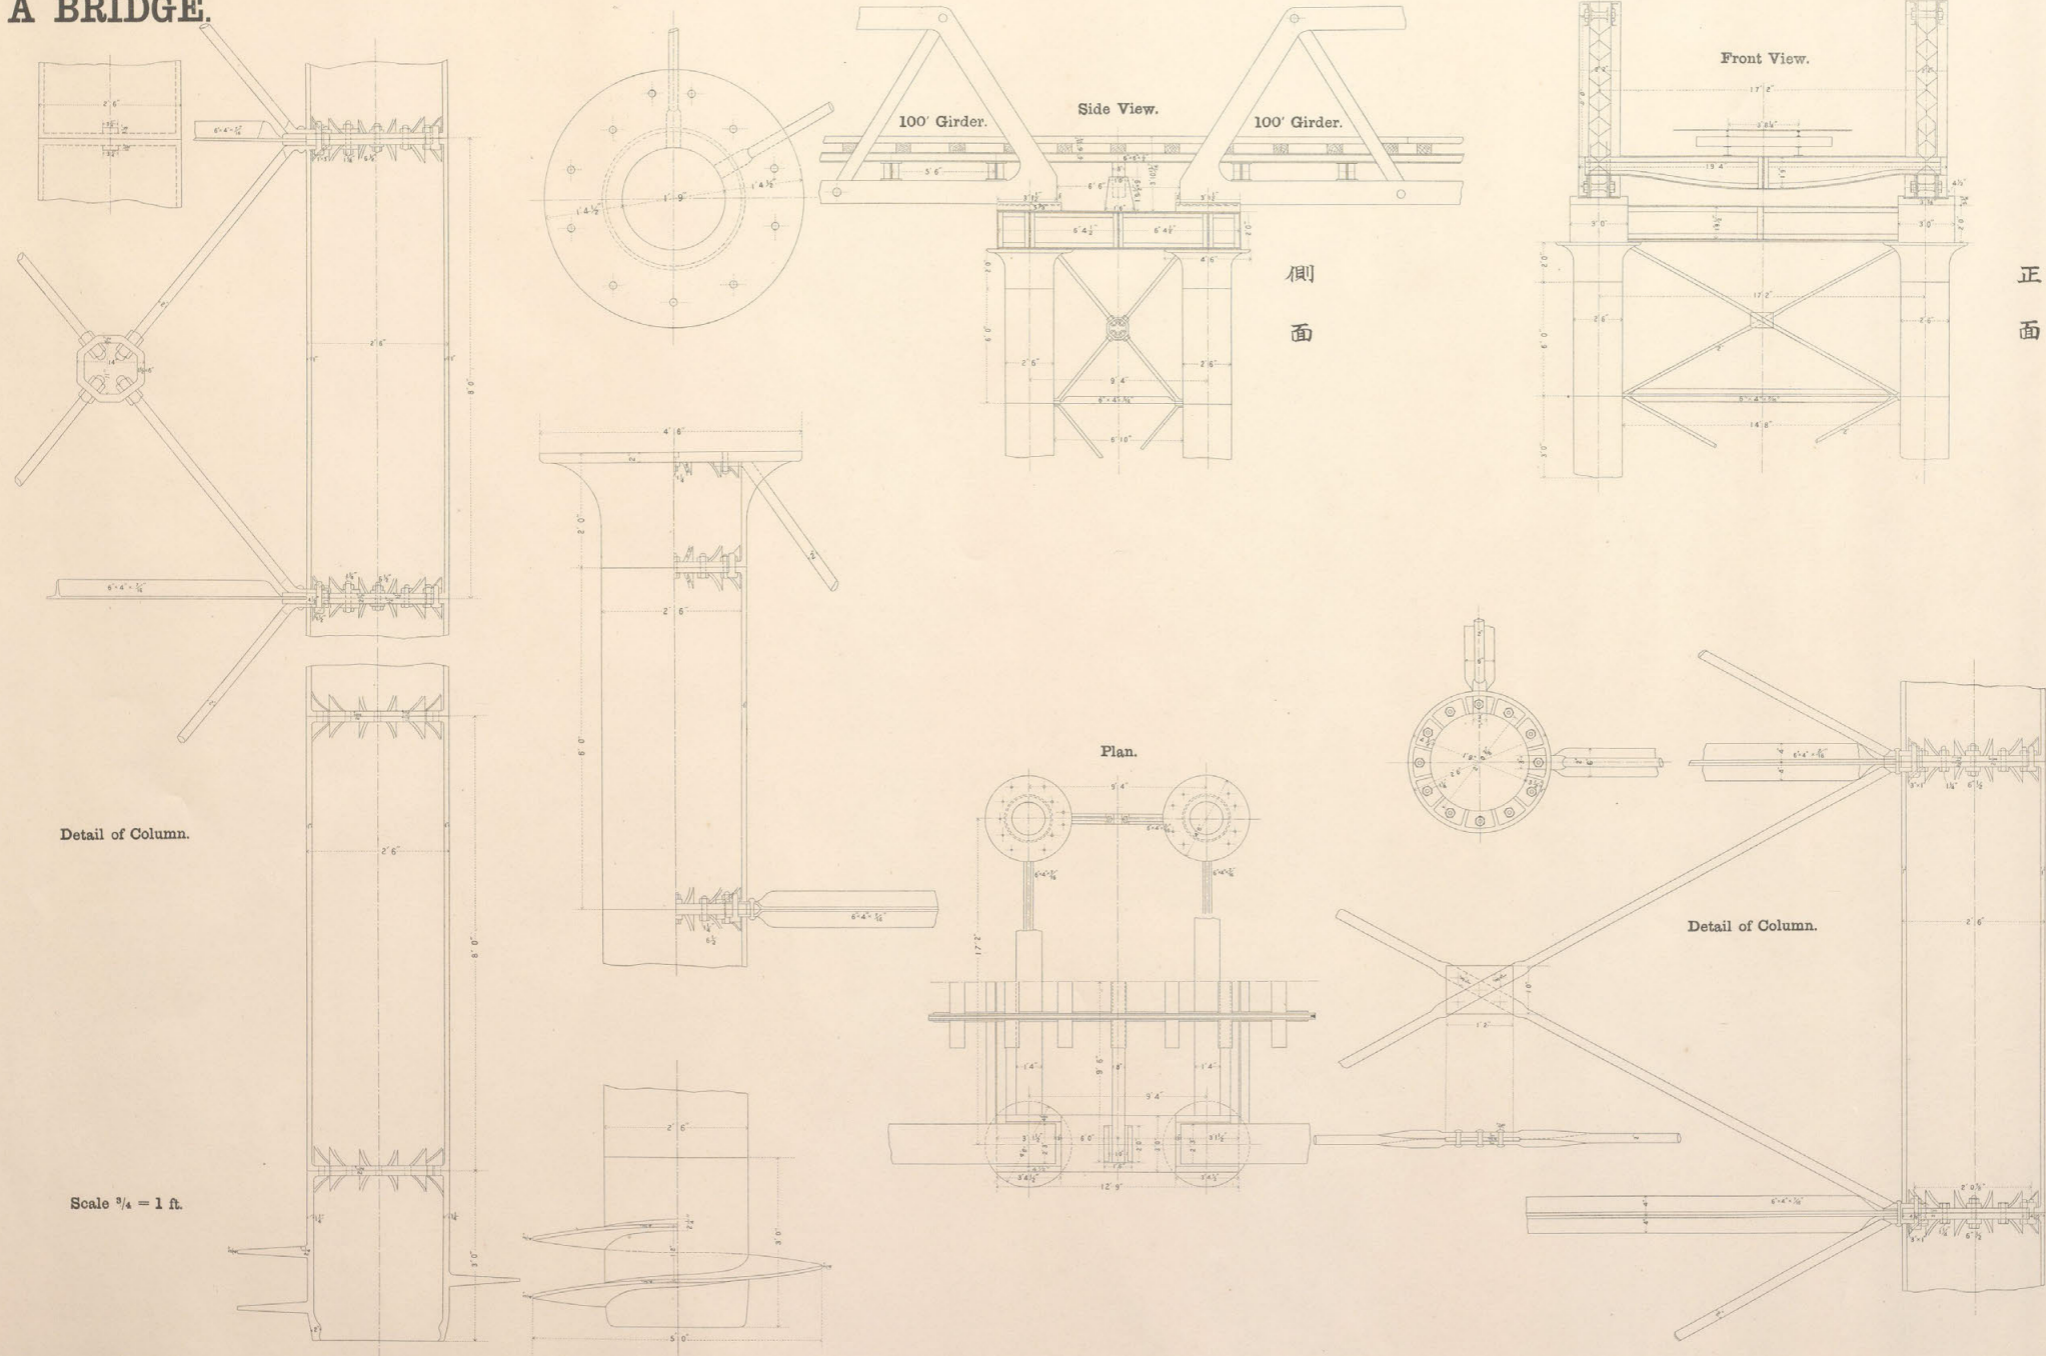
長良川橋脚明細圖(其二)

舊橋川良長 CAST IRON SCREW PILE PIER

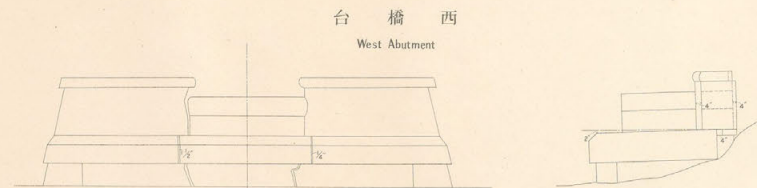
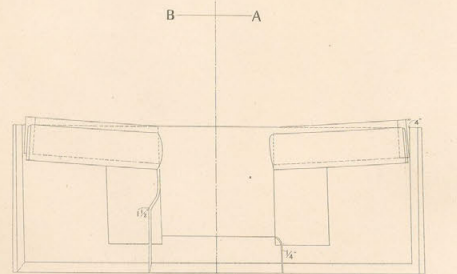
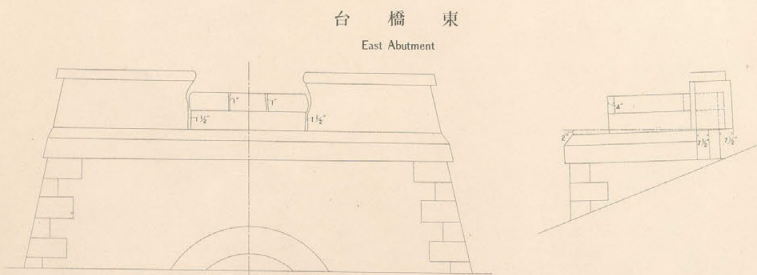
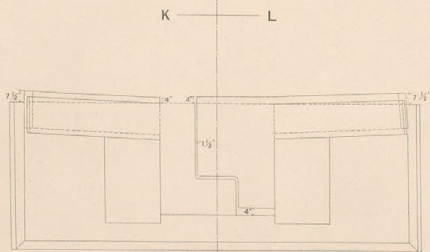
Pier No. 4.
脚橋四第

Showing the condition after the earthquake disaster of Oct. 28th, 1891.
 All the piers, each consisting of a pair of brick columns, 12' in diameter, broken a few feet above low water level and displaced a few inches in various directions.
 The west abutment settled down 1 foot and badly cracked.
 Scale: 20 ft. to an inch.

Showing the condition after the earth
